SANIBEL CAUSEWAY: REBUILDING WITH TEAMWORK AND DETERMINATION

WTBA – 2024 ANNUAL CONVENTION

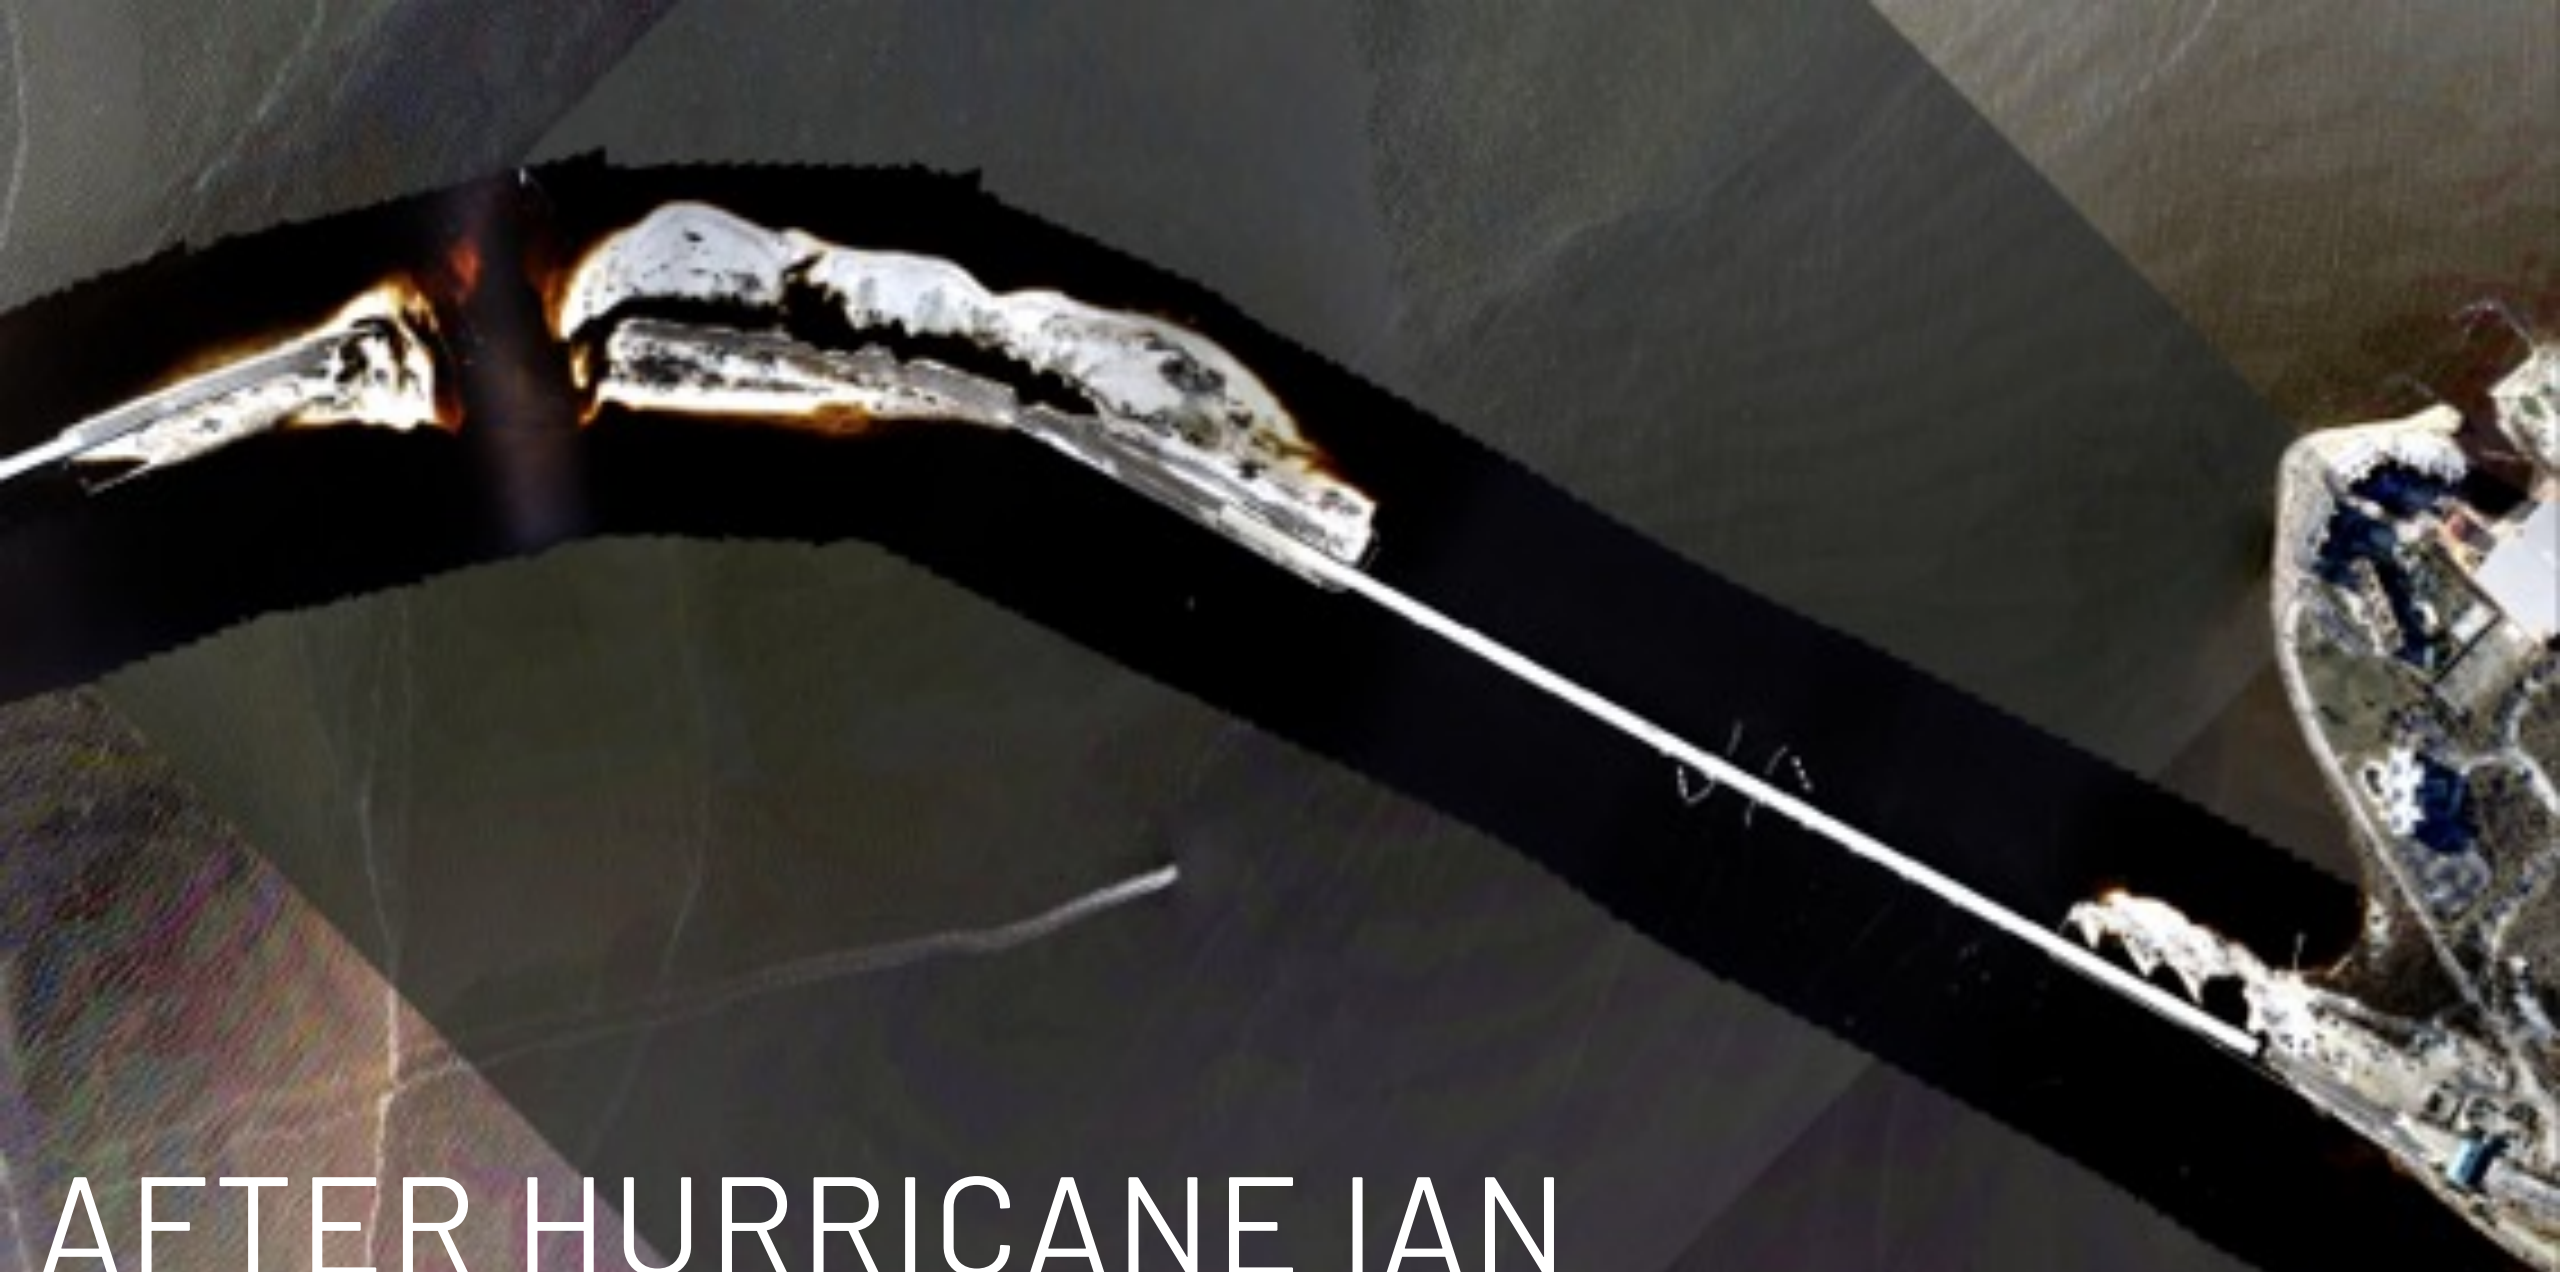
AFTER HURRICANE IAN

Sanibel Causeway Island A & Mainland

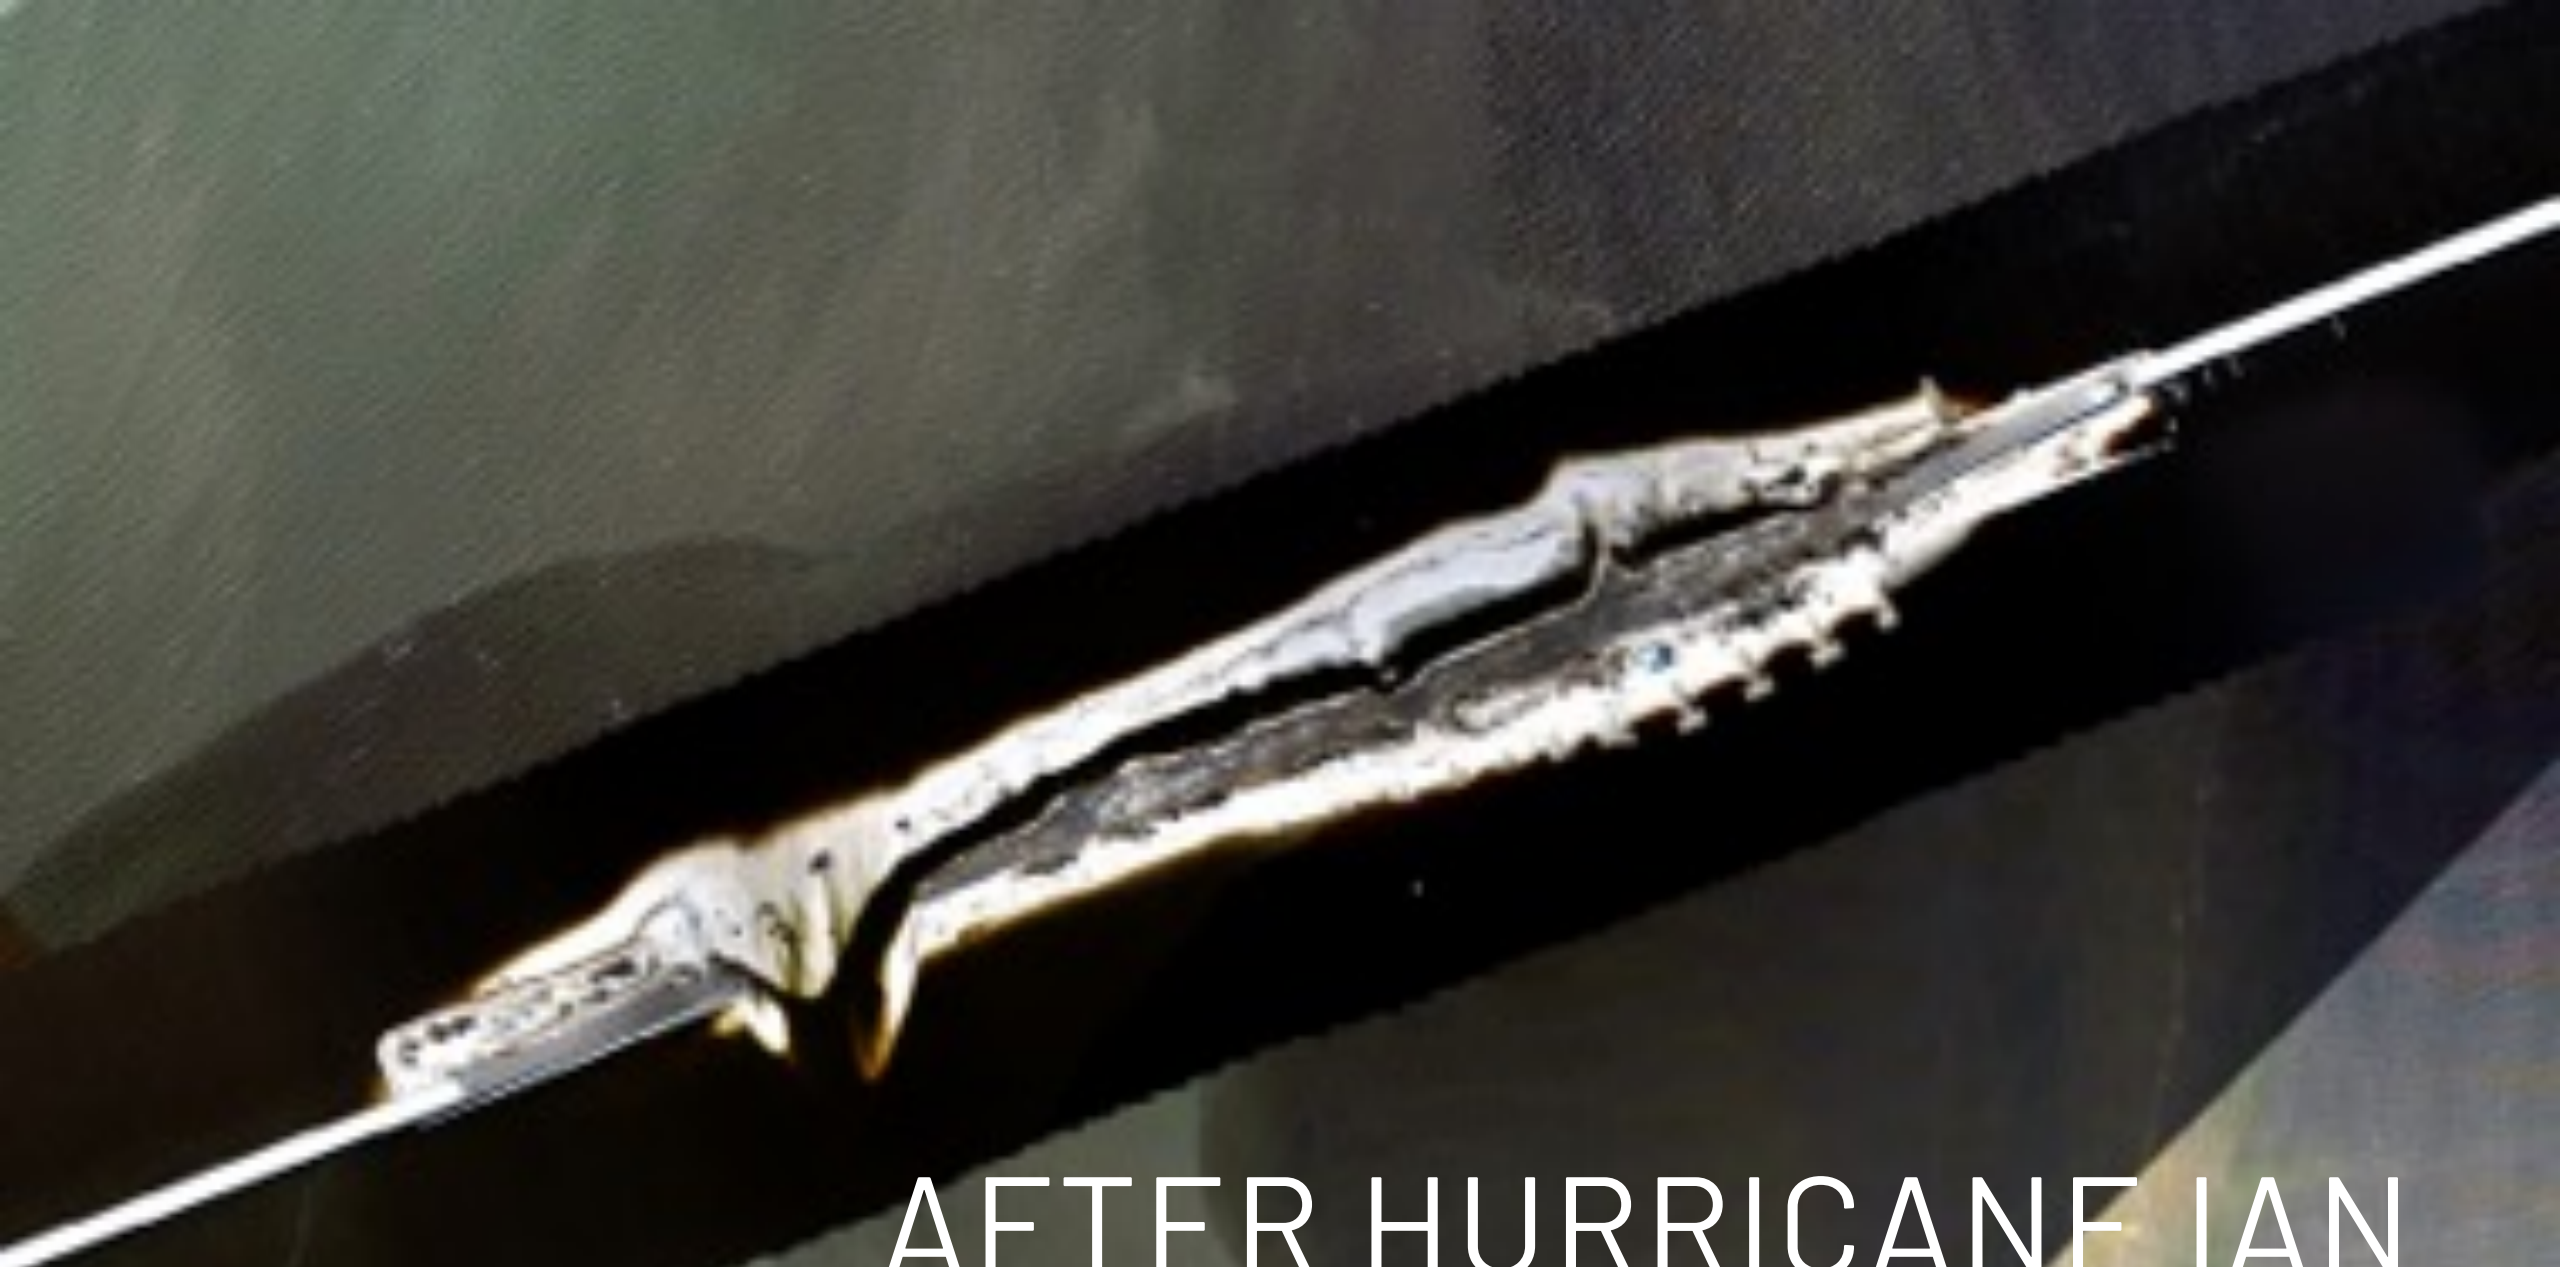
AFTER HURRICANE IAN

Sanibel Causeway Island B

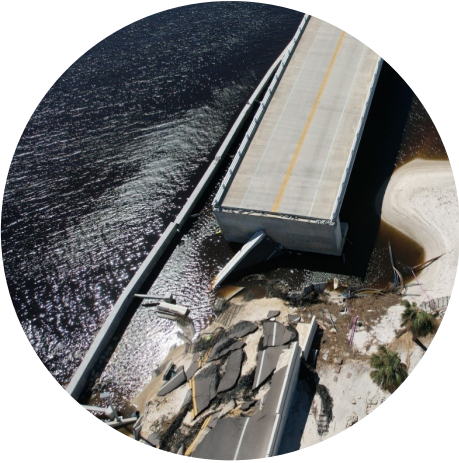
Approach Failures

Sanibel A - East & West Approach
Sanibel B - East & West Approach
Sanibel C - East Approach

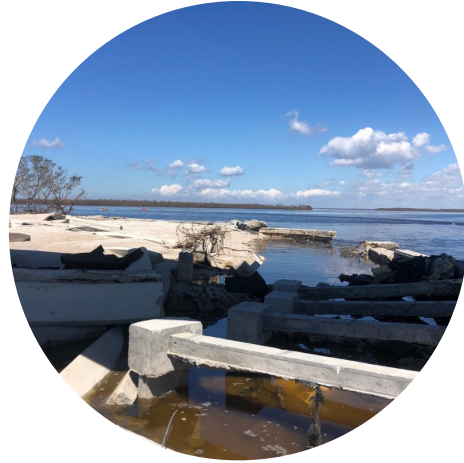
Seawalls

Sanibel A - East & West Side
Sanibel B - East & West Side
Sanibel C - East Side

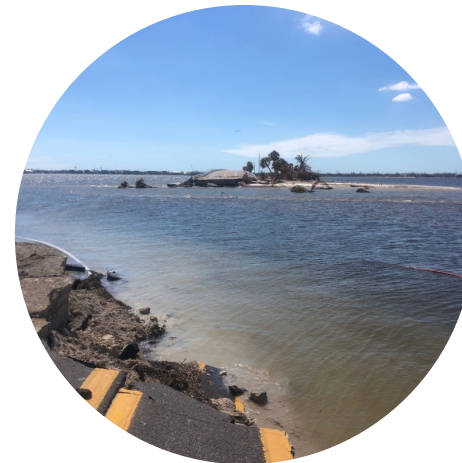
Island Washouts

Island A - Complete Washout
Island B - Complete Washout

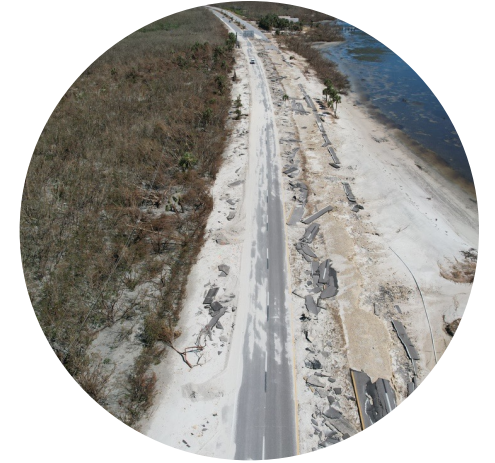
Mainland

McGregor Blvd Eastbound Lanes
Pipe Crossing Failure at Port Comfort

- Not initially identified
- Aerial footage shows loss of material
- Required investigation and repair
- AJAX crews mobilize to location & install temporary repairs

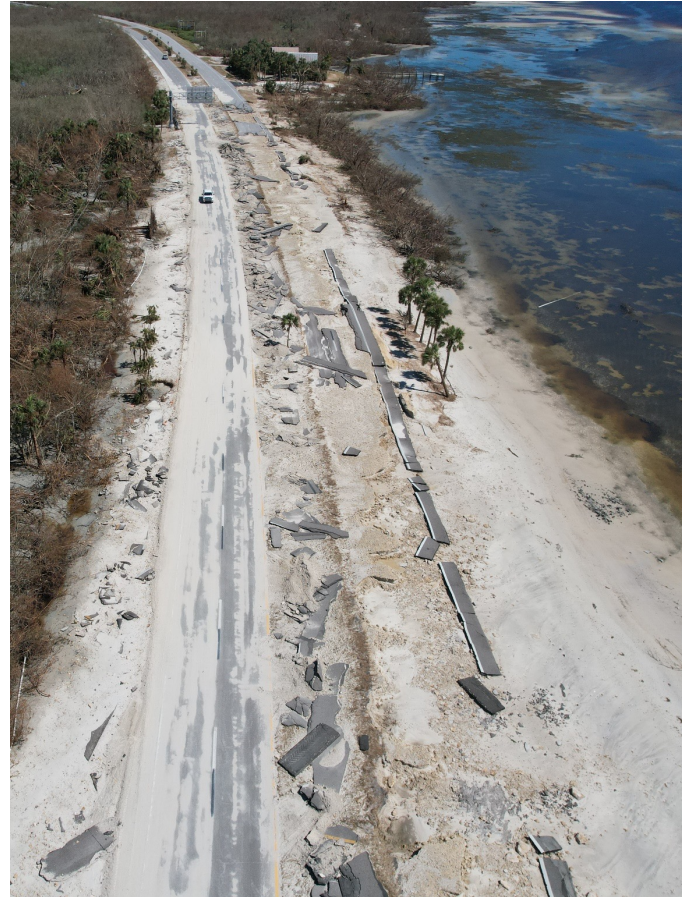
McGregor Boulevard – Damage Assessment

Damages

- Complete washout of eastbound lanes
- Localized damage in westbound lanes
- Signalization and lighting damage
- Drainage system failures

Repairs Needed Immediately

- Provide for deliveries
- Access to boat ramp and barges
- Staging area for barge traffic & construction equipment

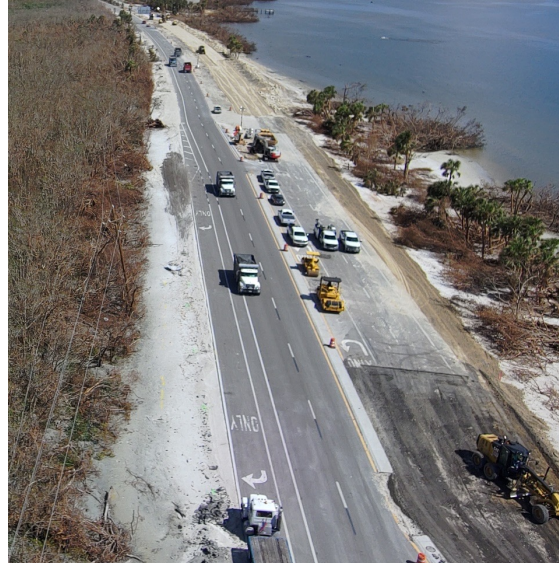
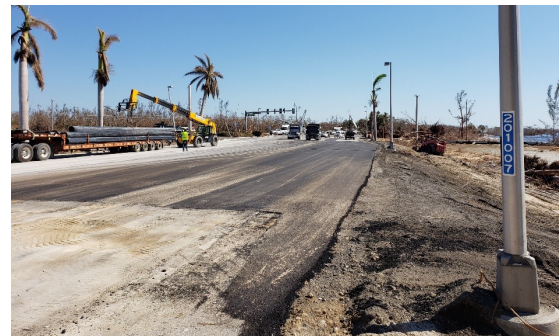
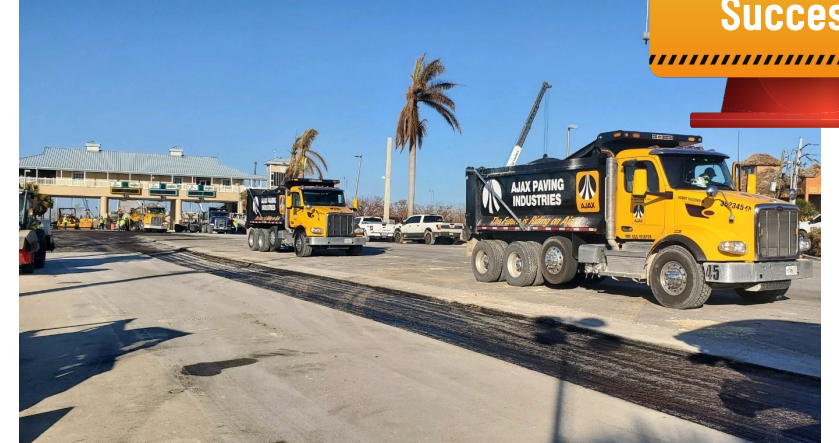
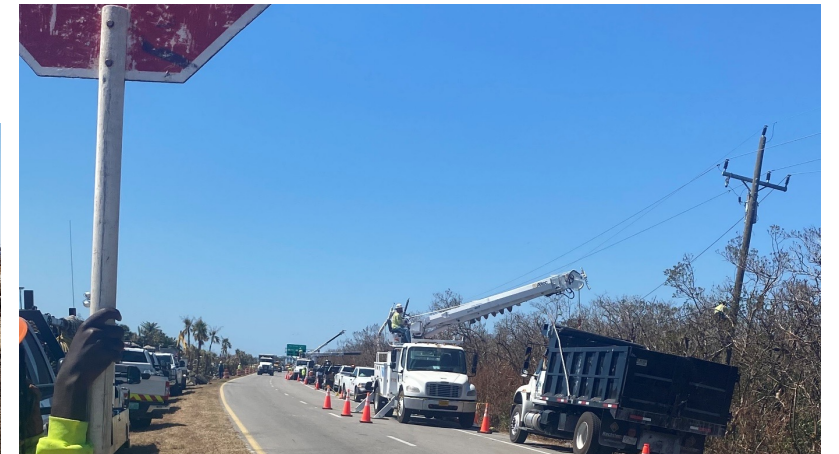
McGregor Boulevard Repairs

Daytime Paving Operation

Disruptions to Batching Operations

- AJAX Alico Rd asphalt plant loses power multiple times
- Power company disconnects power while reestablishing electric in local community
- FDOT contacts power company through Emergency Operations Center

Utility Company Lane Closure

- Utility repair begins on McGregor Blvd. during paving operation
- Lane closure with flagging operation set up by Utility Company in work zone

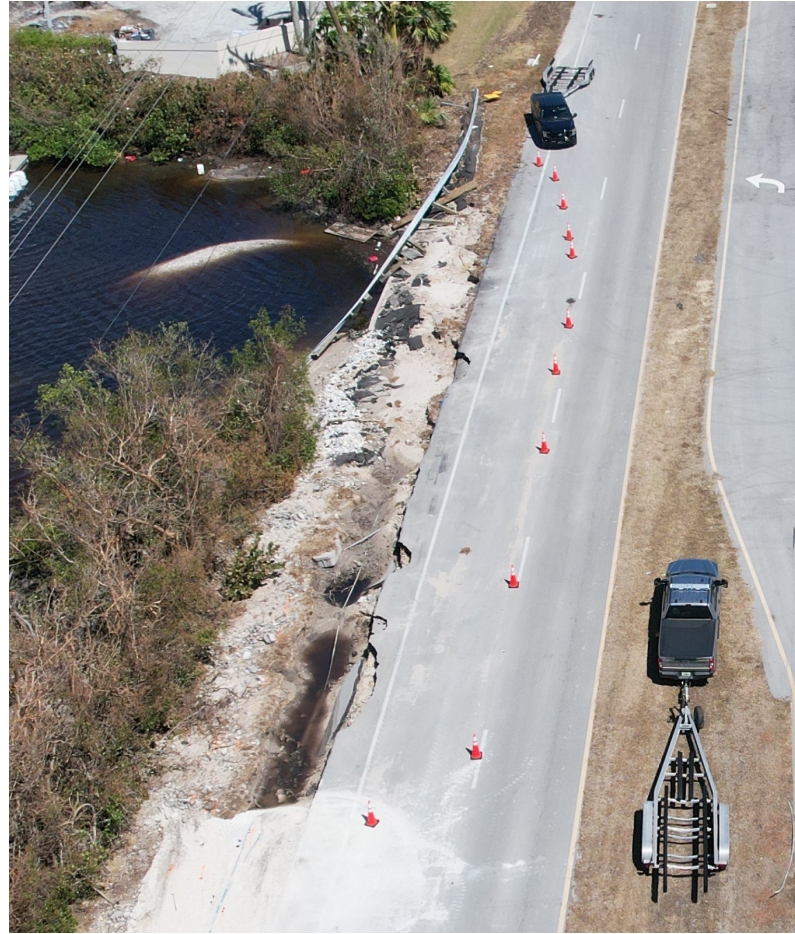
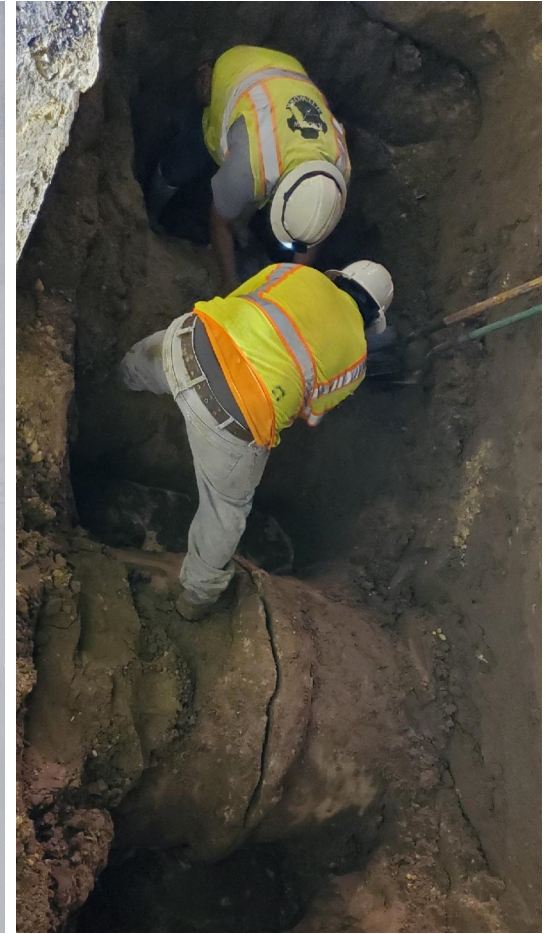
McGregor Boulevard Repairs

Challenge: Depression Forms in Roadway

Port Comfort Pipe Crossing Failures

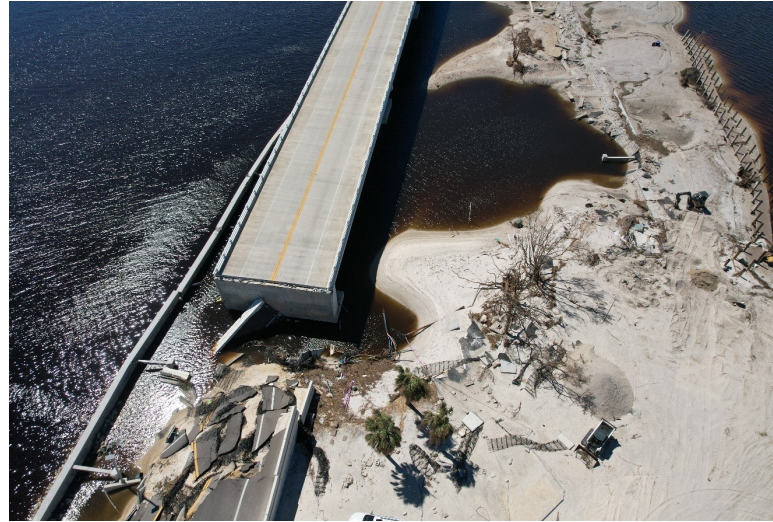
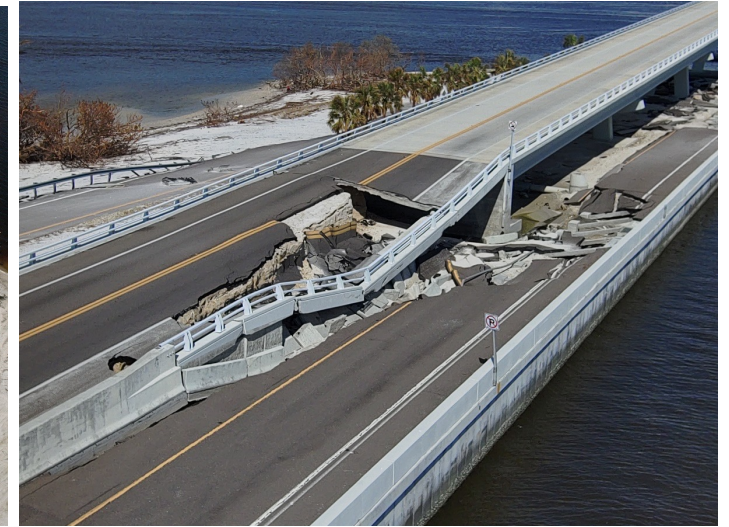
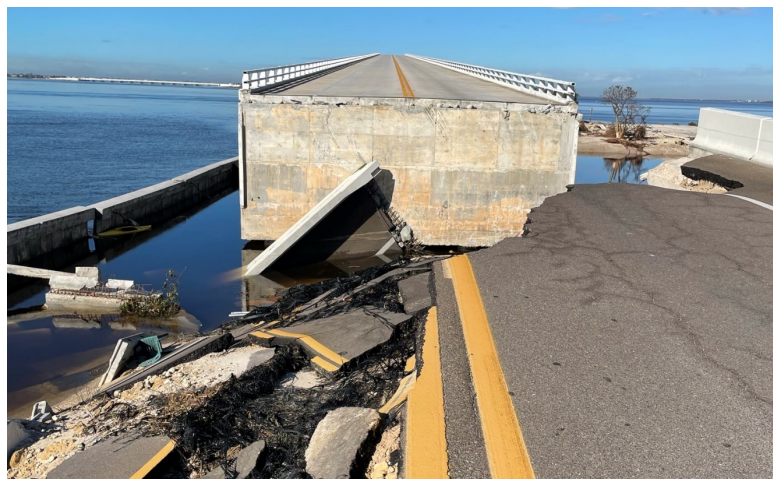
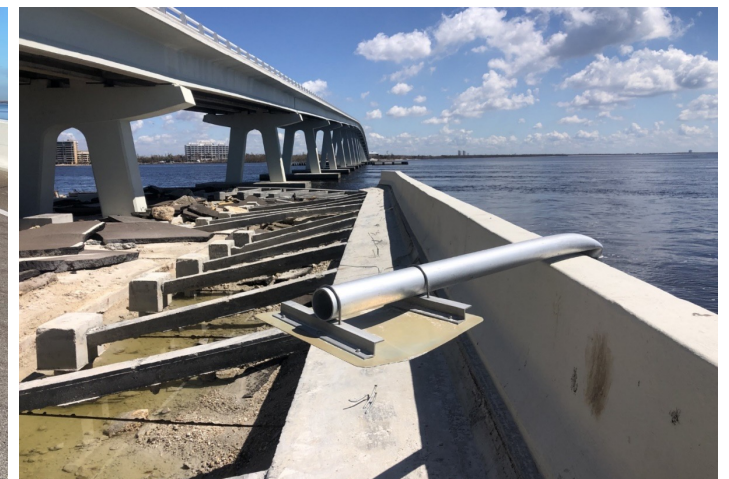
Sanibel A - Damage Assessment

Bridge Approach | MSE Wall Failures

- East & West approaches

Seawall Failures

- East & West abutment

Roadway Failures

- Vicinity of Toll Plaza
- Roadway access under Sanibel A at western abutment

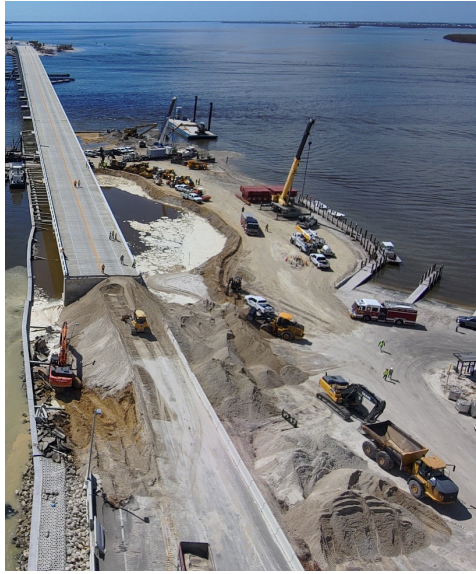
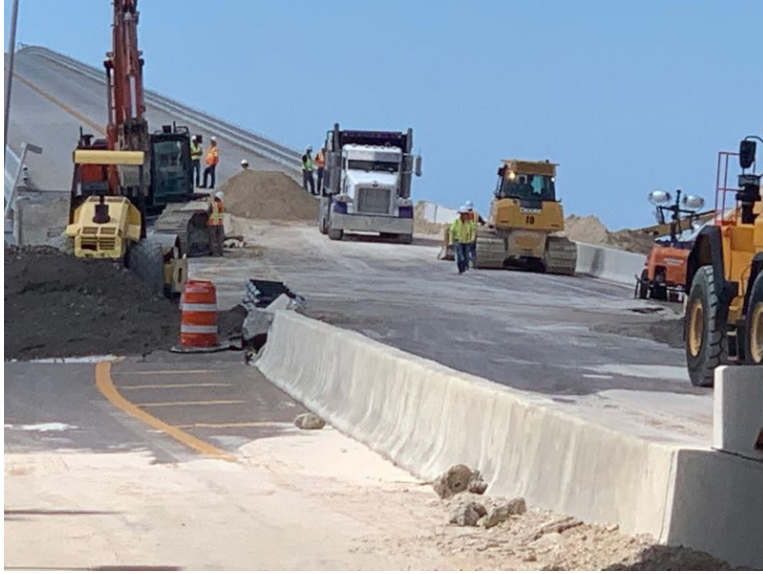
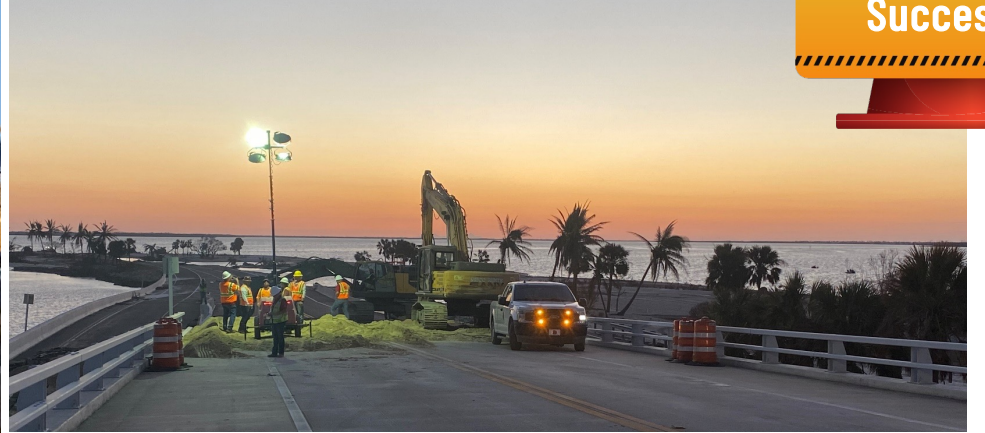
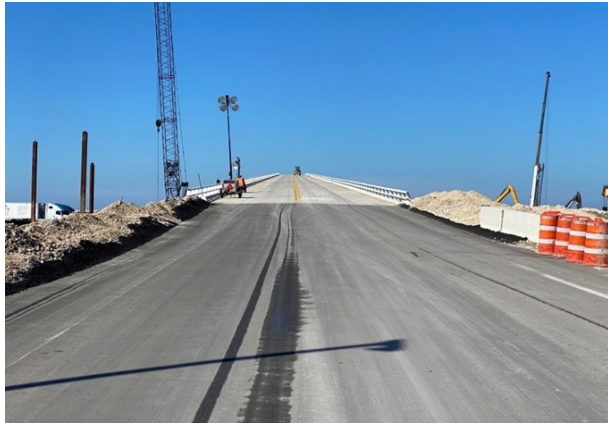
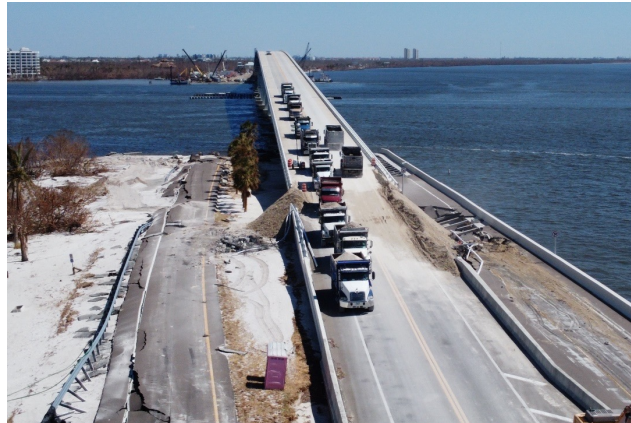
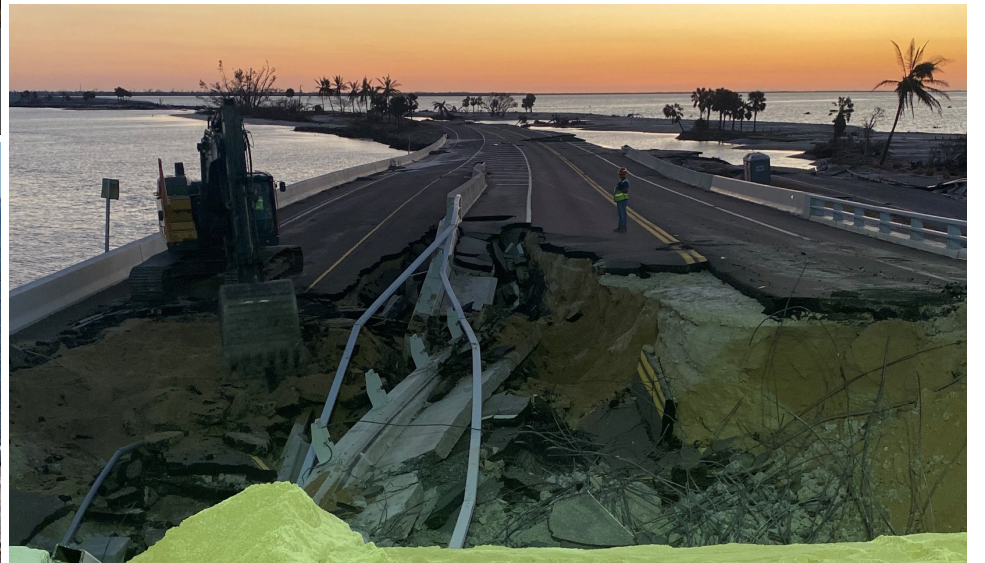
Sanibel A Repairs

Challenge: Drainage from Bridge at Fill Areas. Access to Island A.

Solution: Multiple Simultaneous Work Areas Accessed by Water

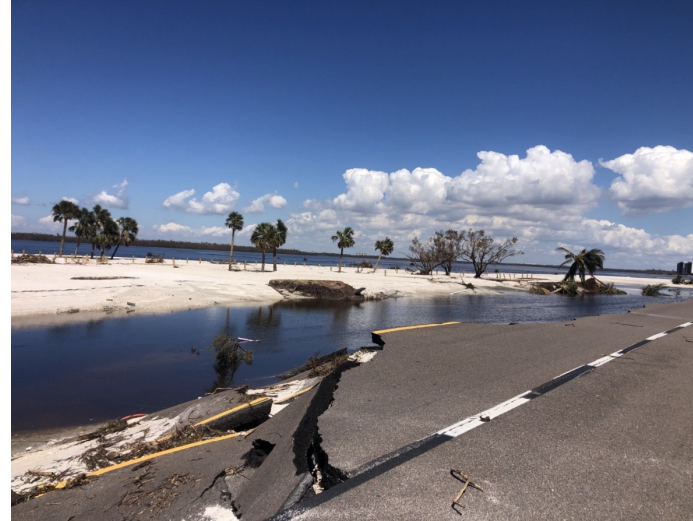
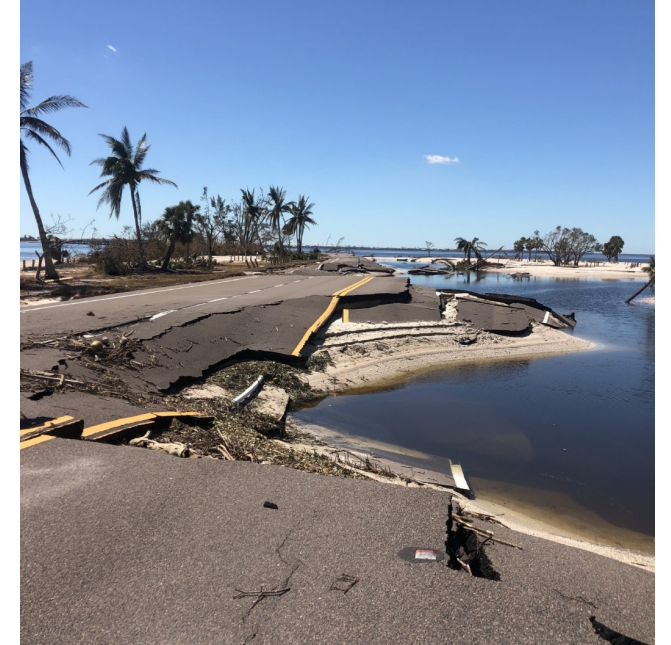
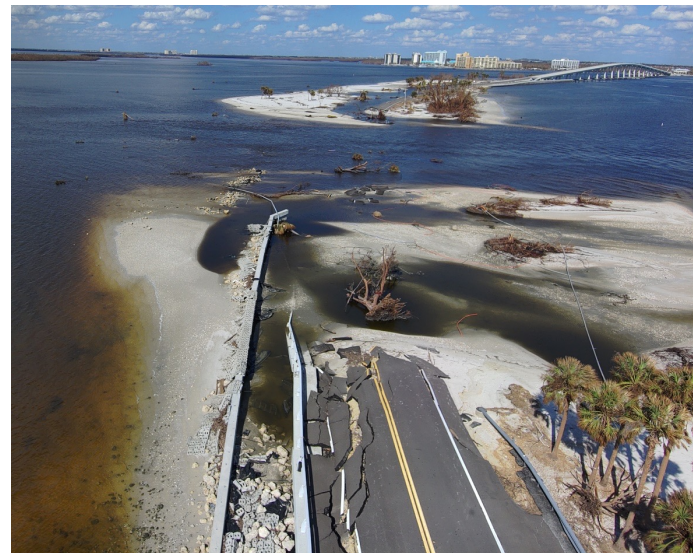
Island A – Damage Assessment

Complete Washout of Island A

- 800 feet wide
- 8.5 feet deep

Actual Impacts Deeper than Anticipated

- Water levels lower during post storm assessments
- Storm produced significant inland flooding that eventually discharged from Caloosahatchee River into San Carlos Bay

Significant Erosion

Complete Loss of Park Facilities

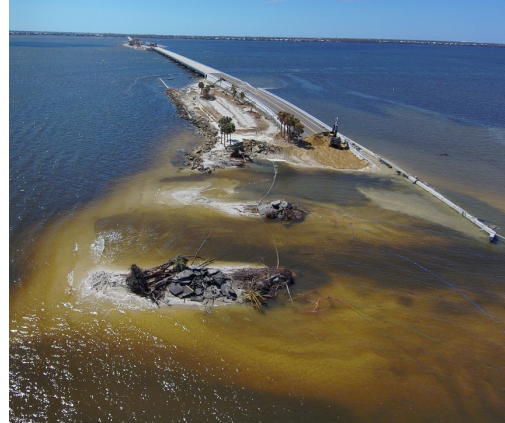
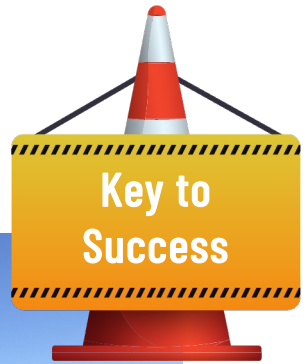
Island A - Repairs

Challenge: Tides & Currents

Closing the Cut

- Experienced fill loss at Island cut due to high tides & fast-moving currents
- Constructed rock jetty out ahead of placing material
- Jetty blocked impacts from tides and currents

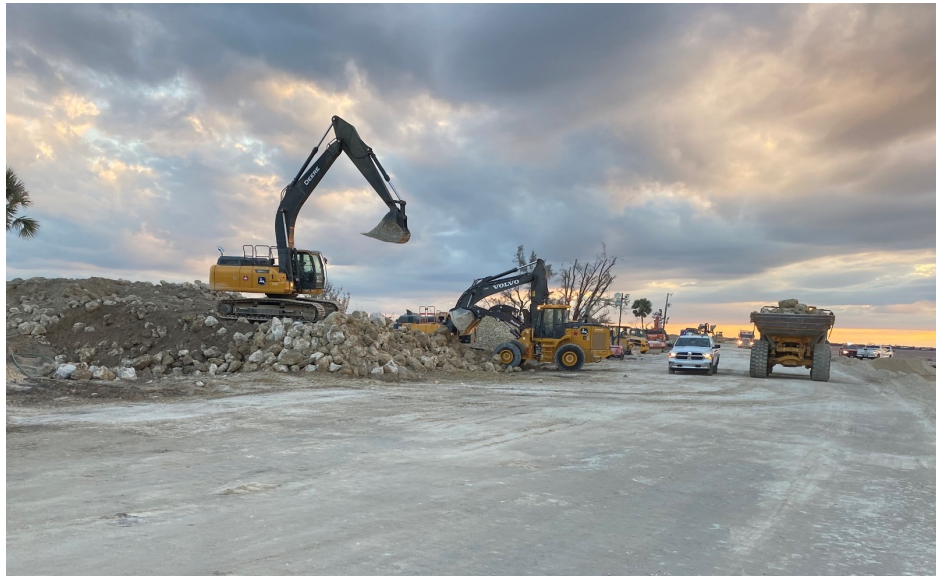
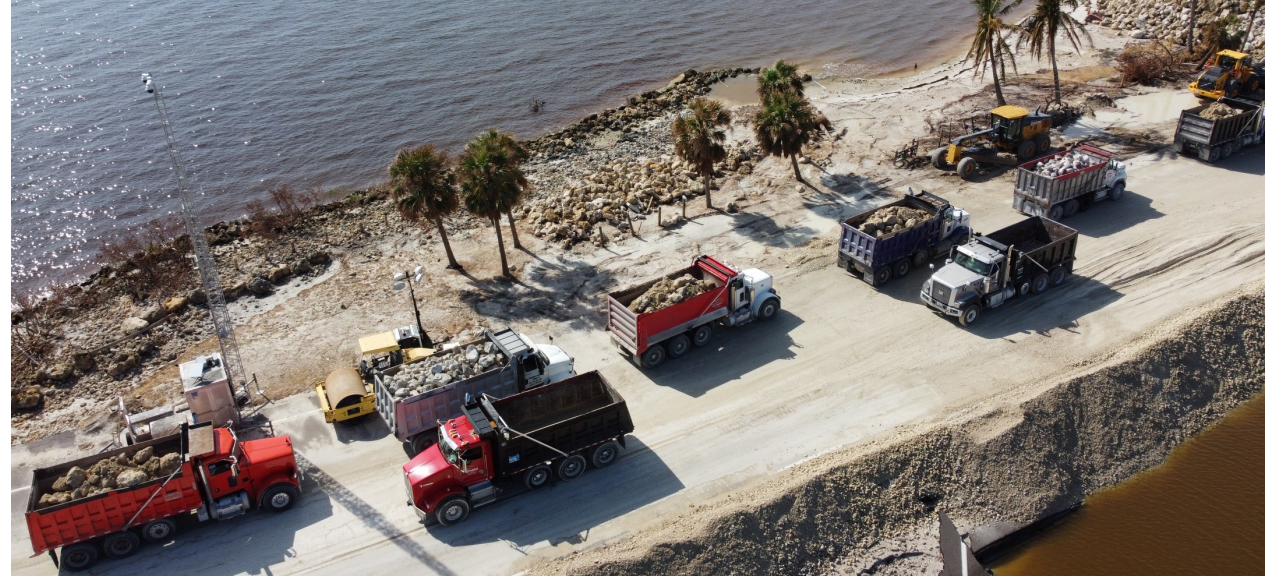
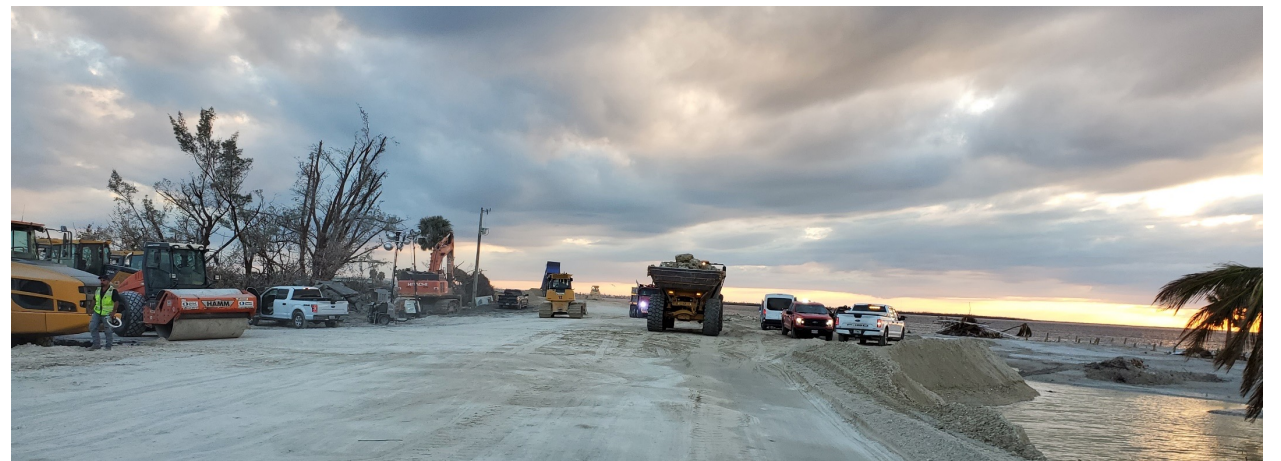
Island A – Repairs

Challenge: Available Work Area

Available Work Area

- Movement of people and equipment
- Significant volume of deliveries
- Placement of materials

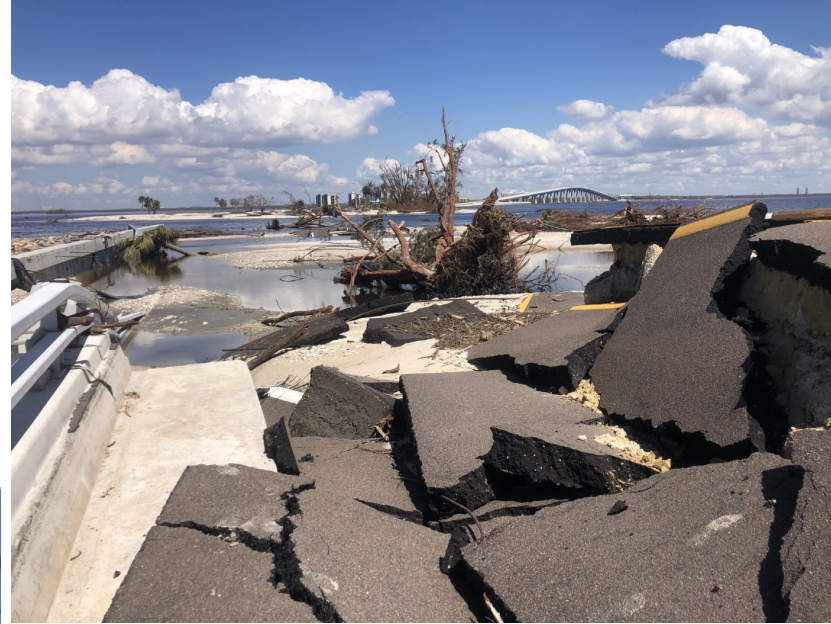
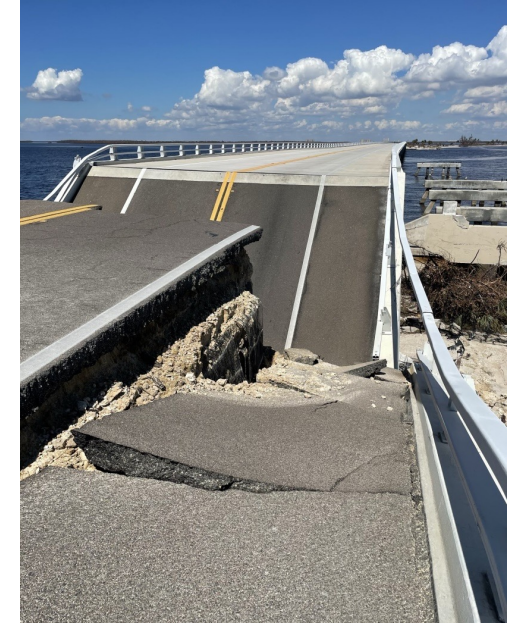
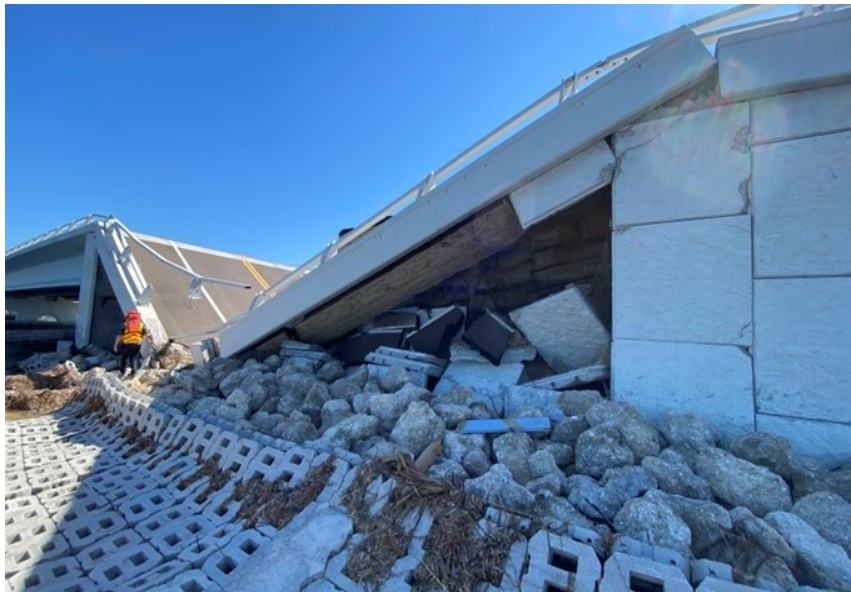
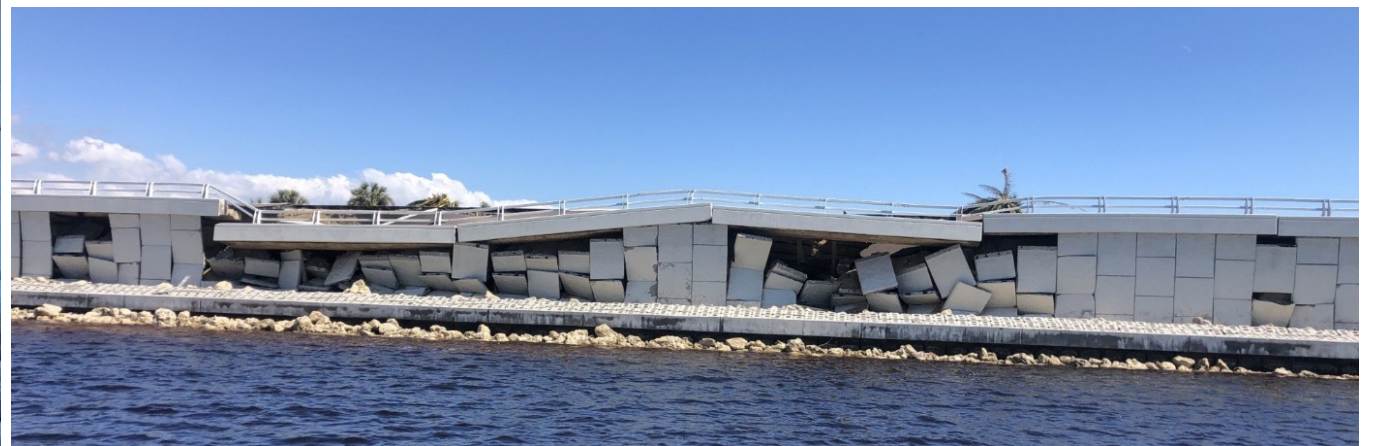
Sanibel B - Damage Assessment

Bridge Approach | MSE Wall Failures

- East & West approaches

Seawall Failures

- East & West abutment

Roadway Failures

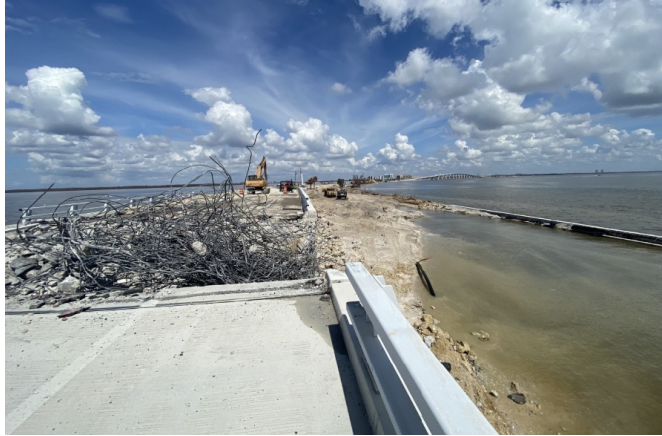
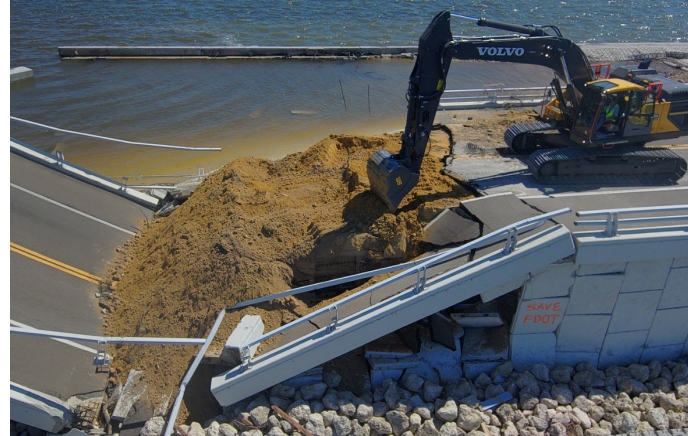
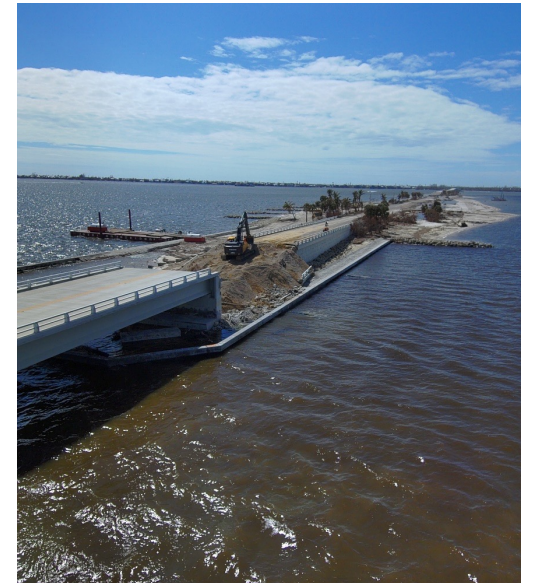
Sanibel B - Repairs

Challenge: Temporary Critical Sheet Pile Wall Needed

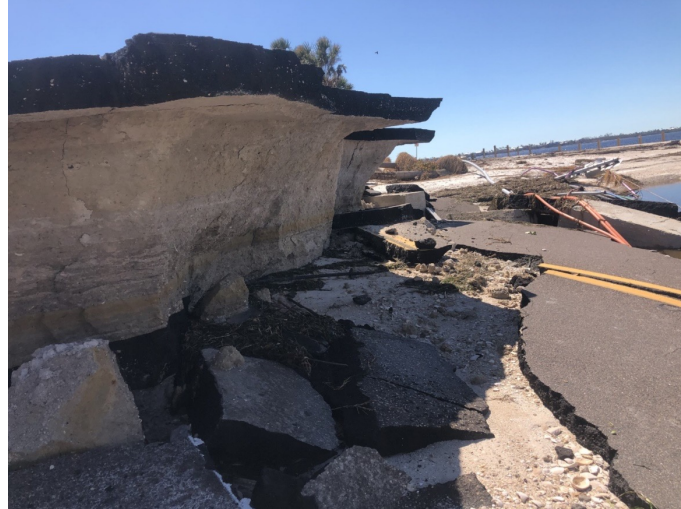
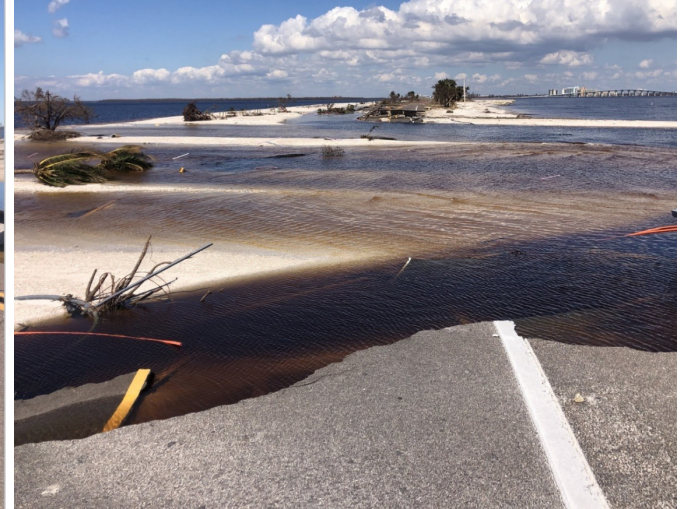
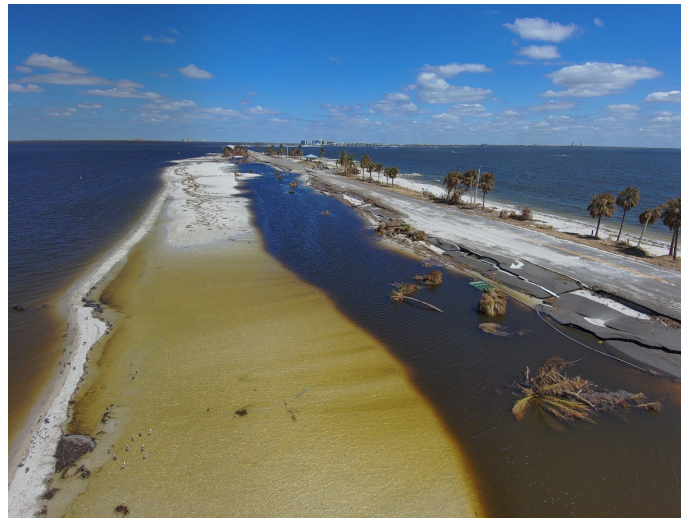
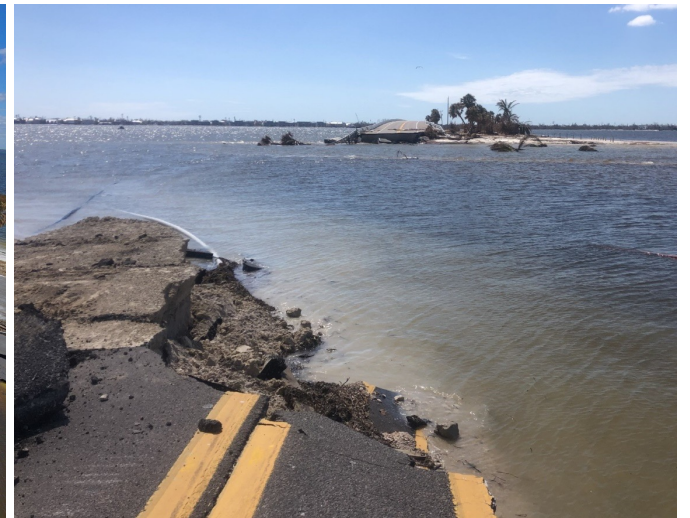
Island B – Damage Assessment

Complete Washout of Island A

- 400 feet wide
- 4.5 feet deep
- Significant Erosion
- Complete Loss of Park Facilities
- Priority to fill void
- Water levels and tides “normalized”
- Constant flow of dredge material helping to fill Island B washout
