SANIBEL CAUSEWAY: REBUILDING WITH TEAMWORK AND DETERMINATION

WTBA – 2024 ANNUAL CONVENTION

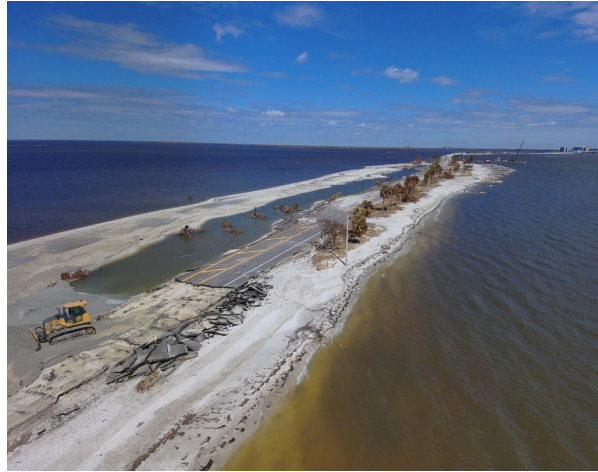
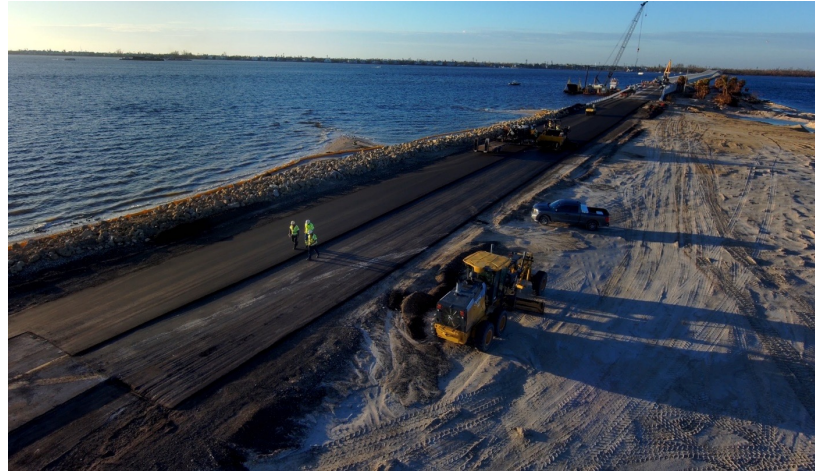
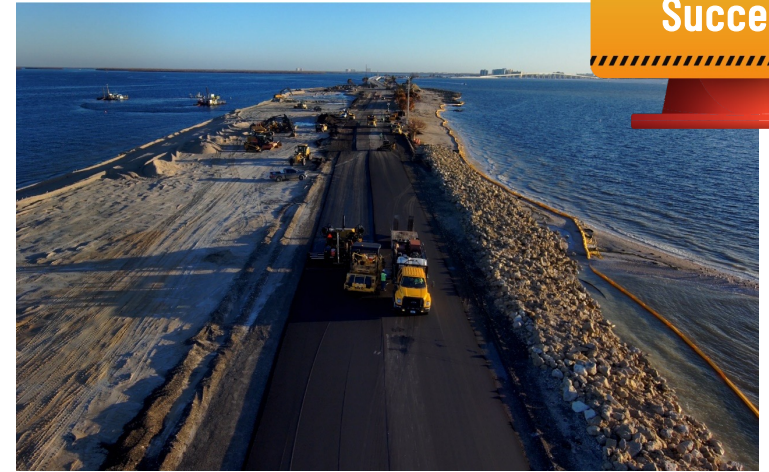
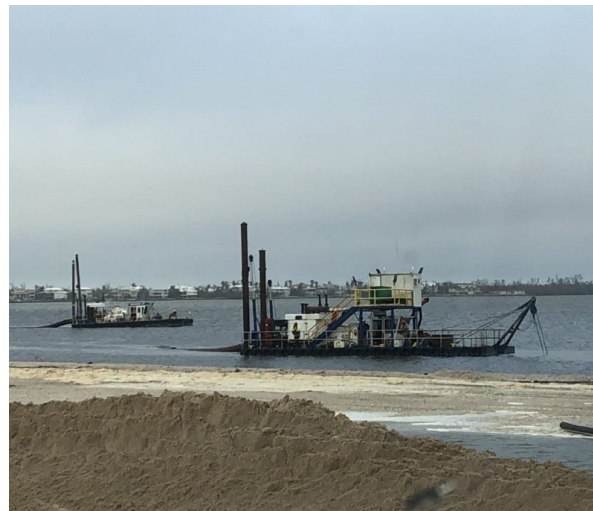
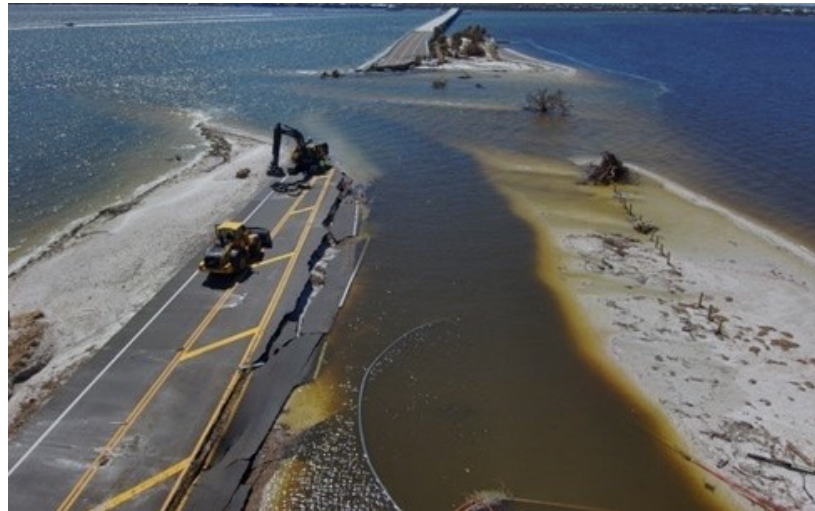
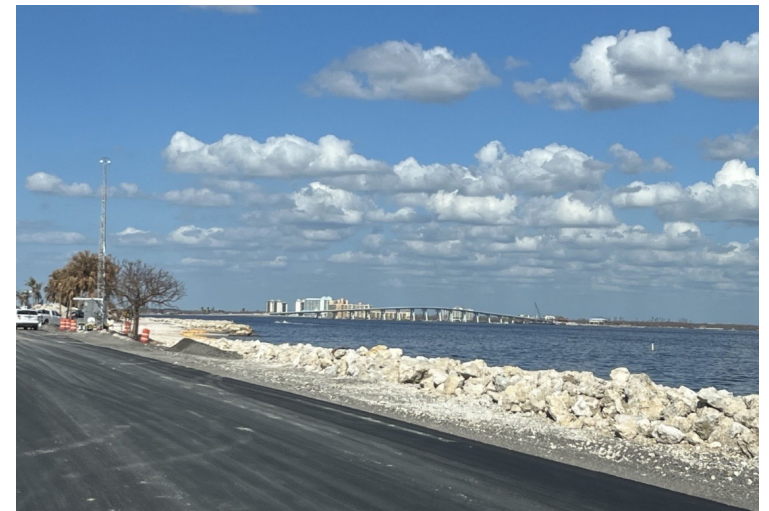
Island B - Repairs

Challenge: Fill Island B Washout to Access Abutment at Bridge C

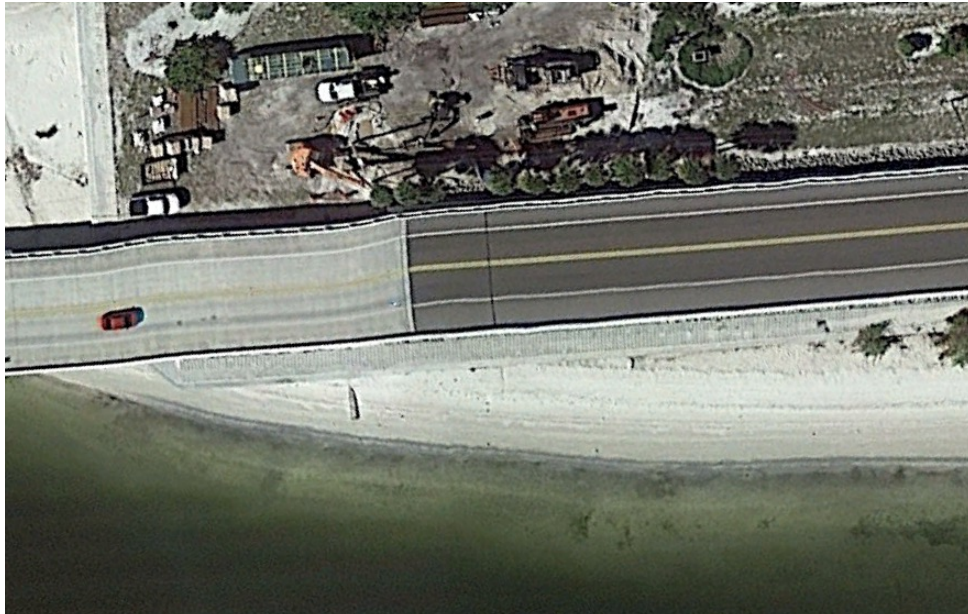
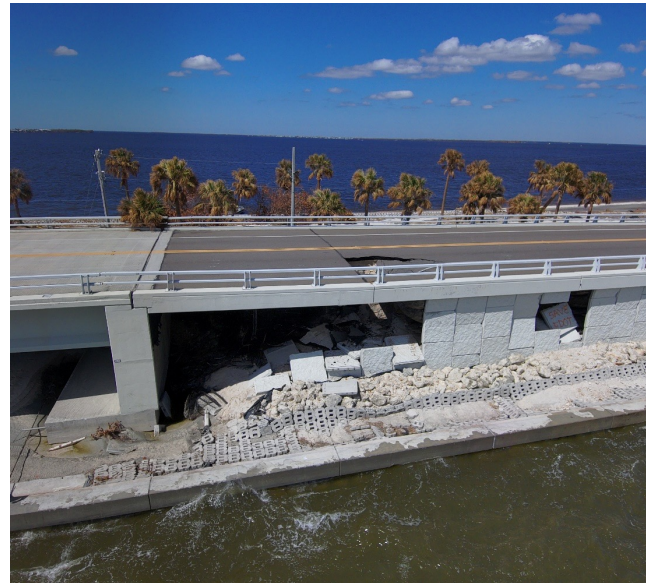
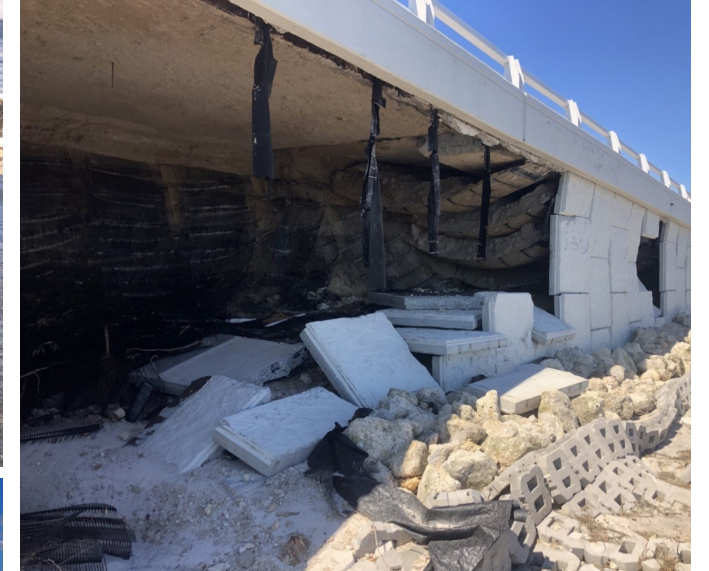
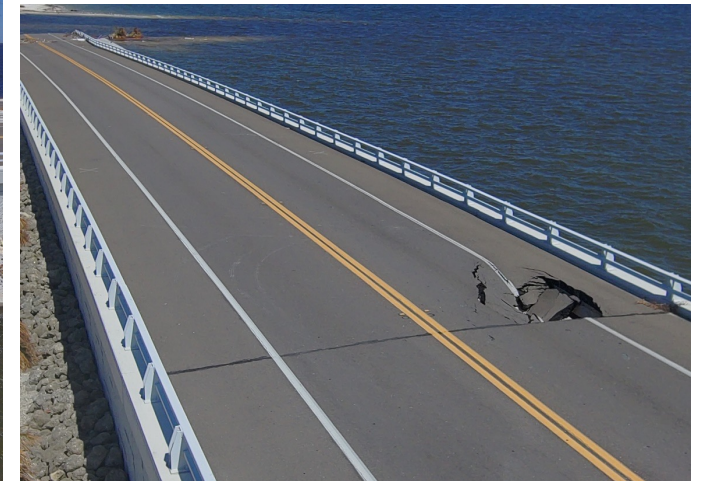
Sanibel C - Damage Assessment

Bridge Approach | MSE Wall Failures

- East approach

Seawall Failures

- East abutment

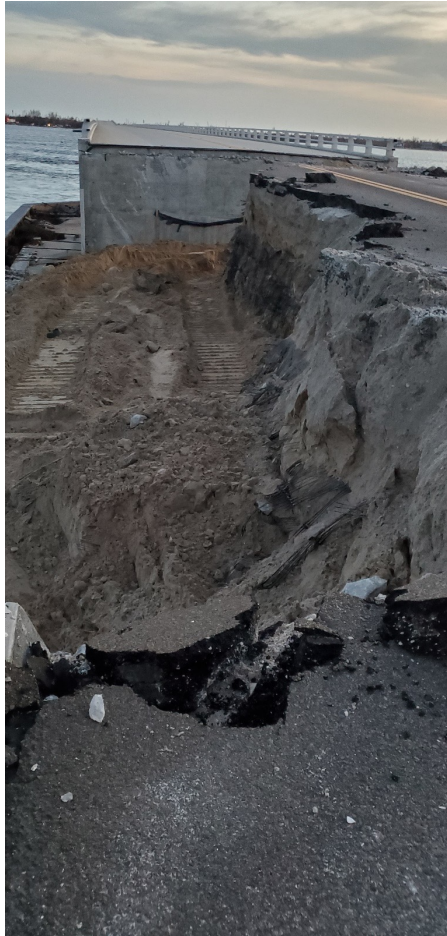
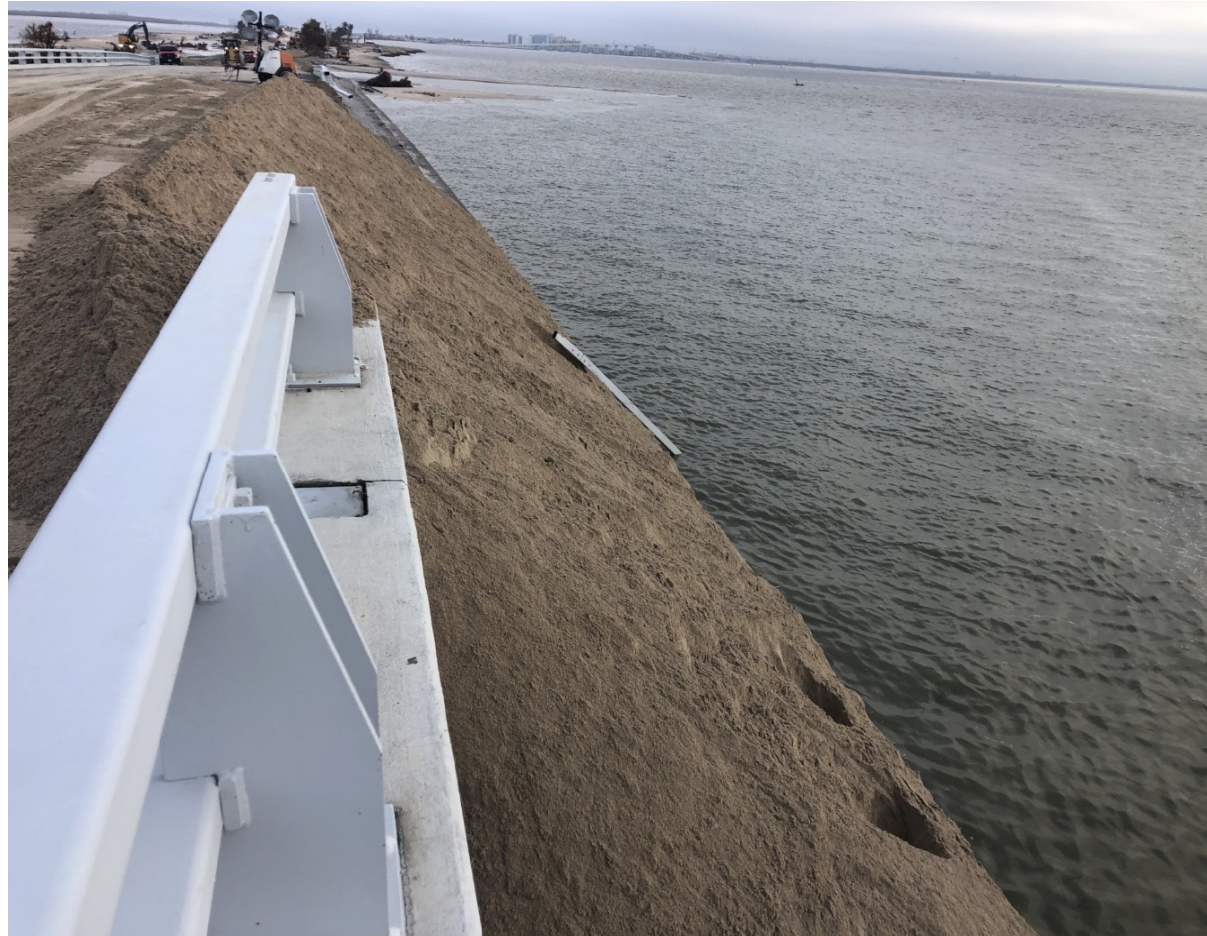
Sanibel C - Repairs

Challenge: Water Depths Caused by Scour

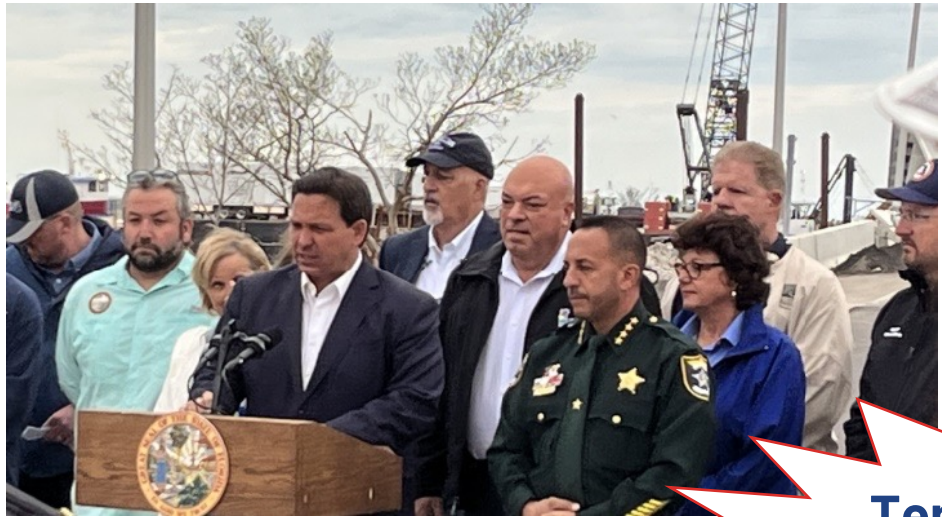
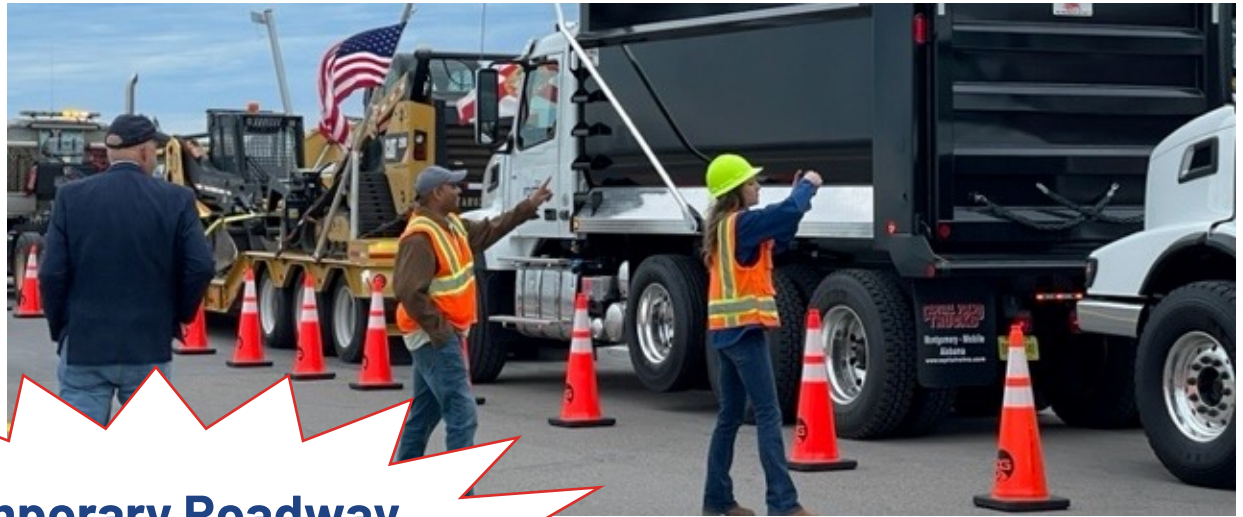
COUNTY OF RECORD	STATE OF FLORIDA	TEMPORARY TRAFFIC CONTROL		SHEET NO.
LAPORTE A. BRITTON, P.E. LICENSED PROFESSIONAL ENGINEER 7715 N. W. STEVENS BLVD. SUITE 400 LAKELAND, FL 33809	DEPARTMENT OF TRANSPORTATION STATE ROAD DISTRICT 10 CR 867	LEE	PLAN (7)

This checkpoint moves east. Vehicles not permitted on Sanibel will be diverted into the turn lane to Punta Rassa Rd. via traffic control officer direction.

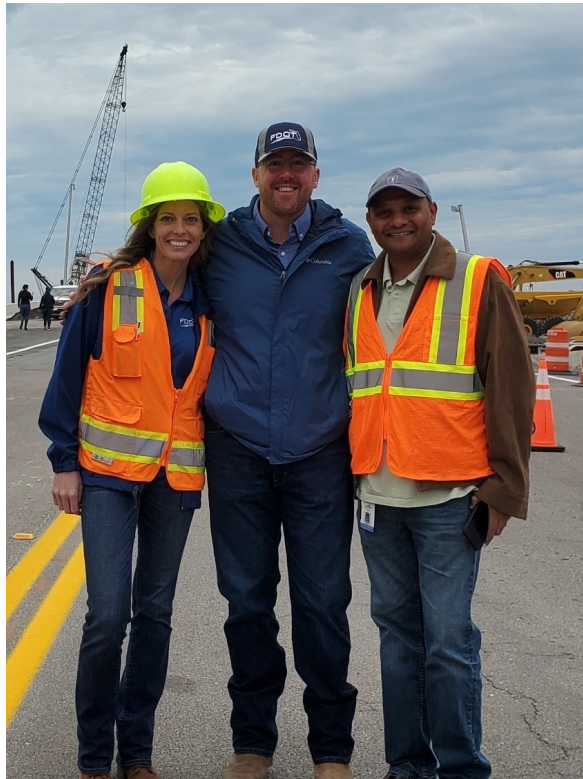
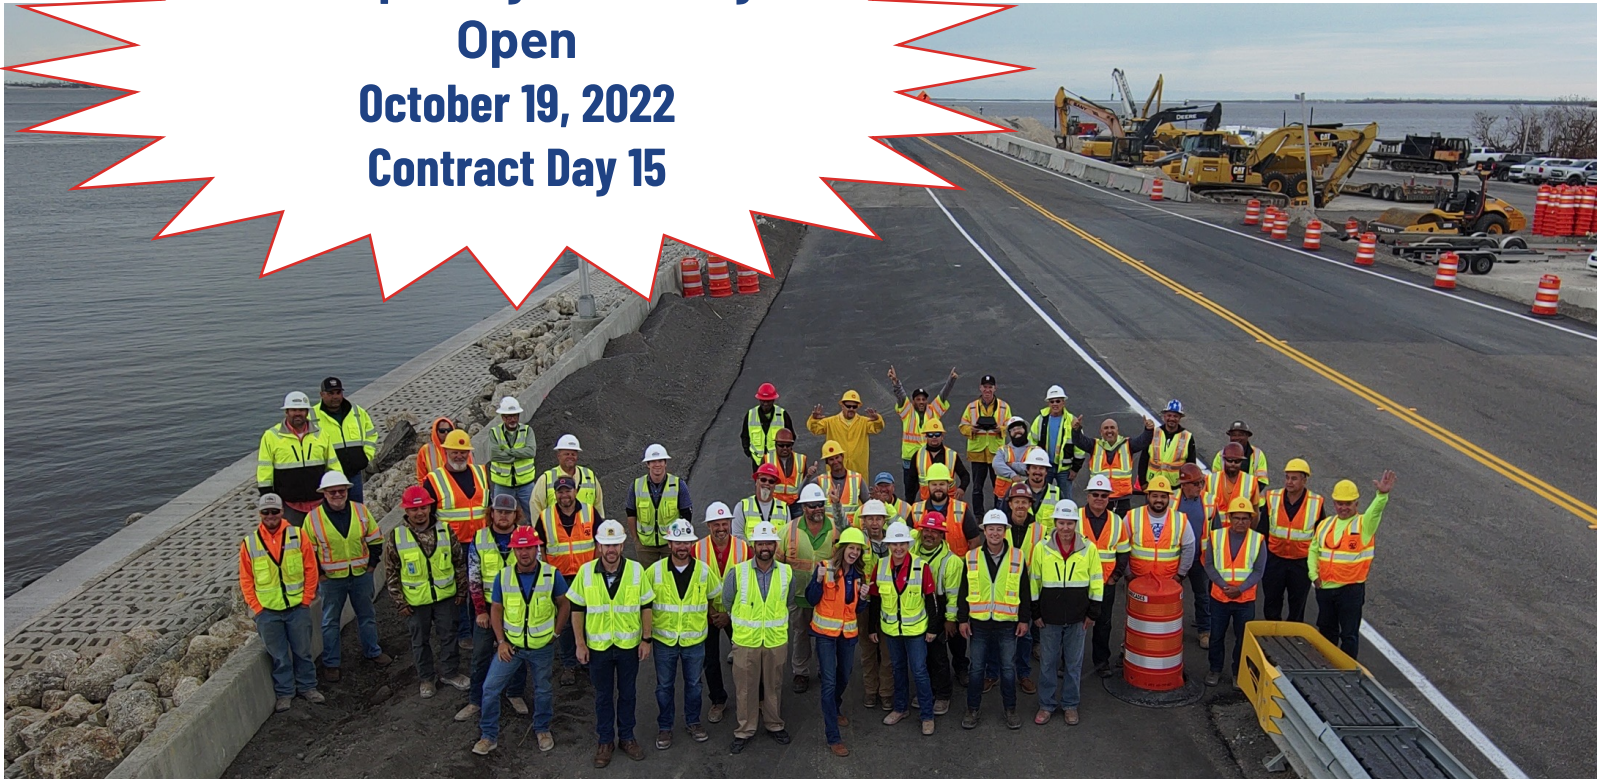
**Temporary Roadway
Open
October 19, 2022
Contract Day 15**

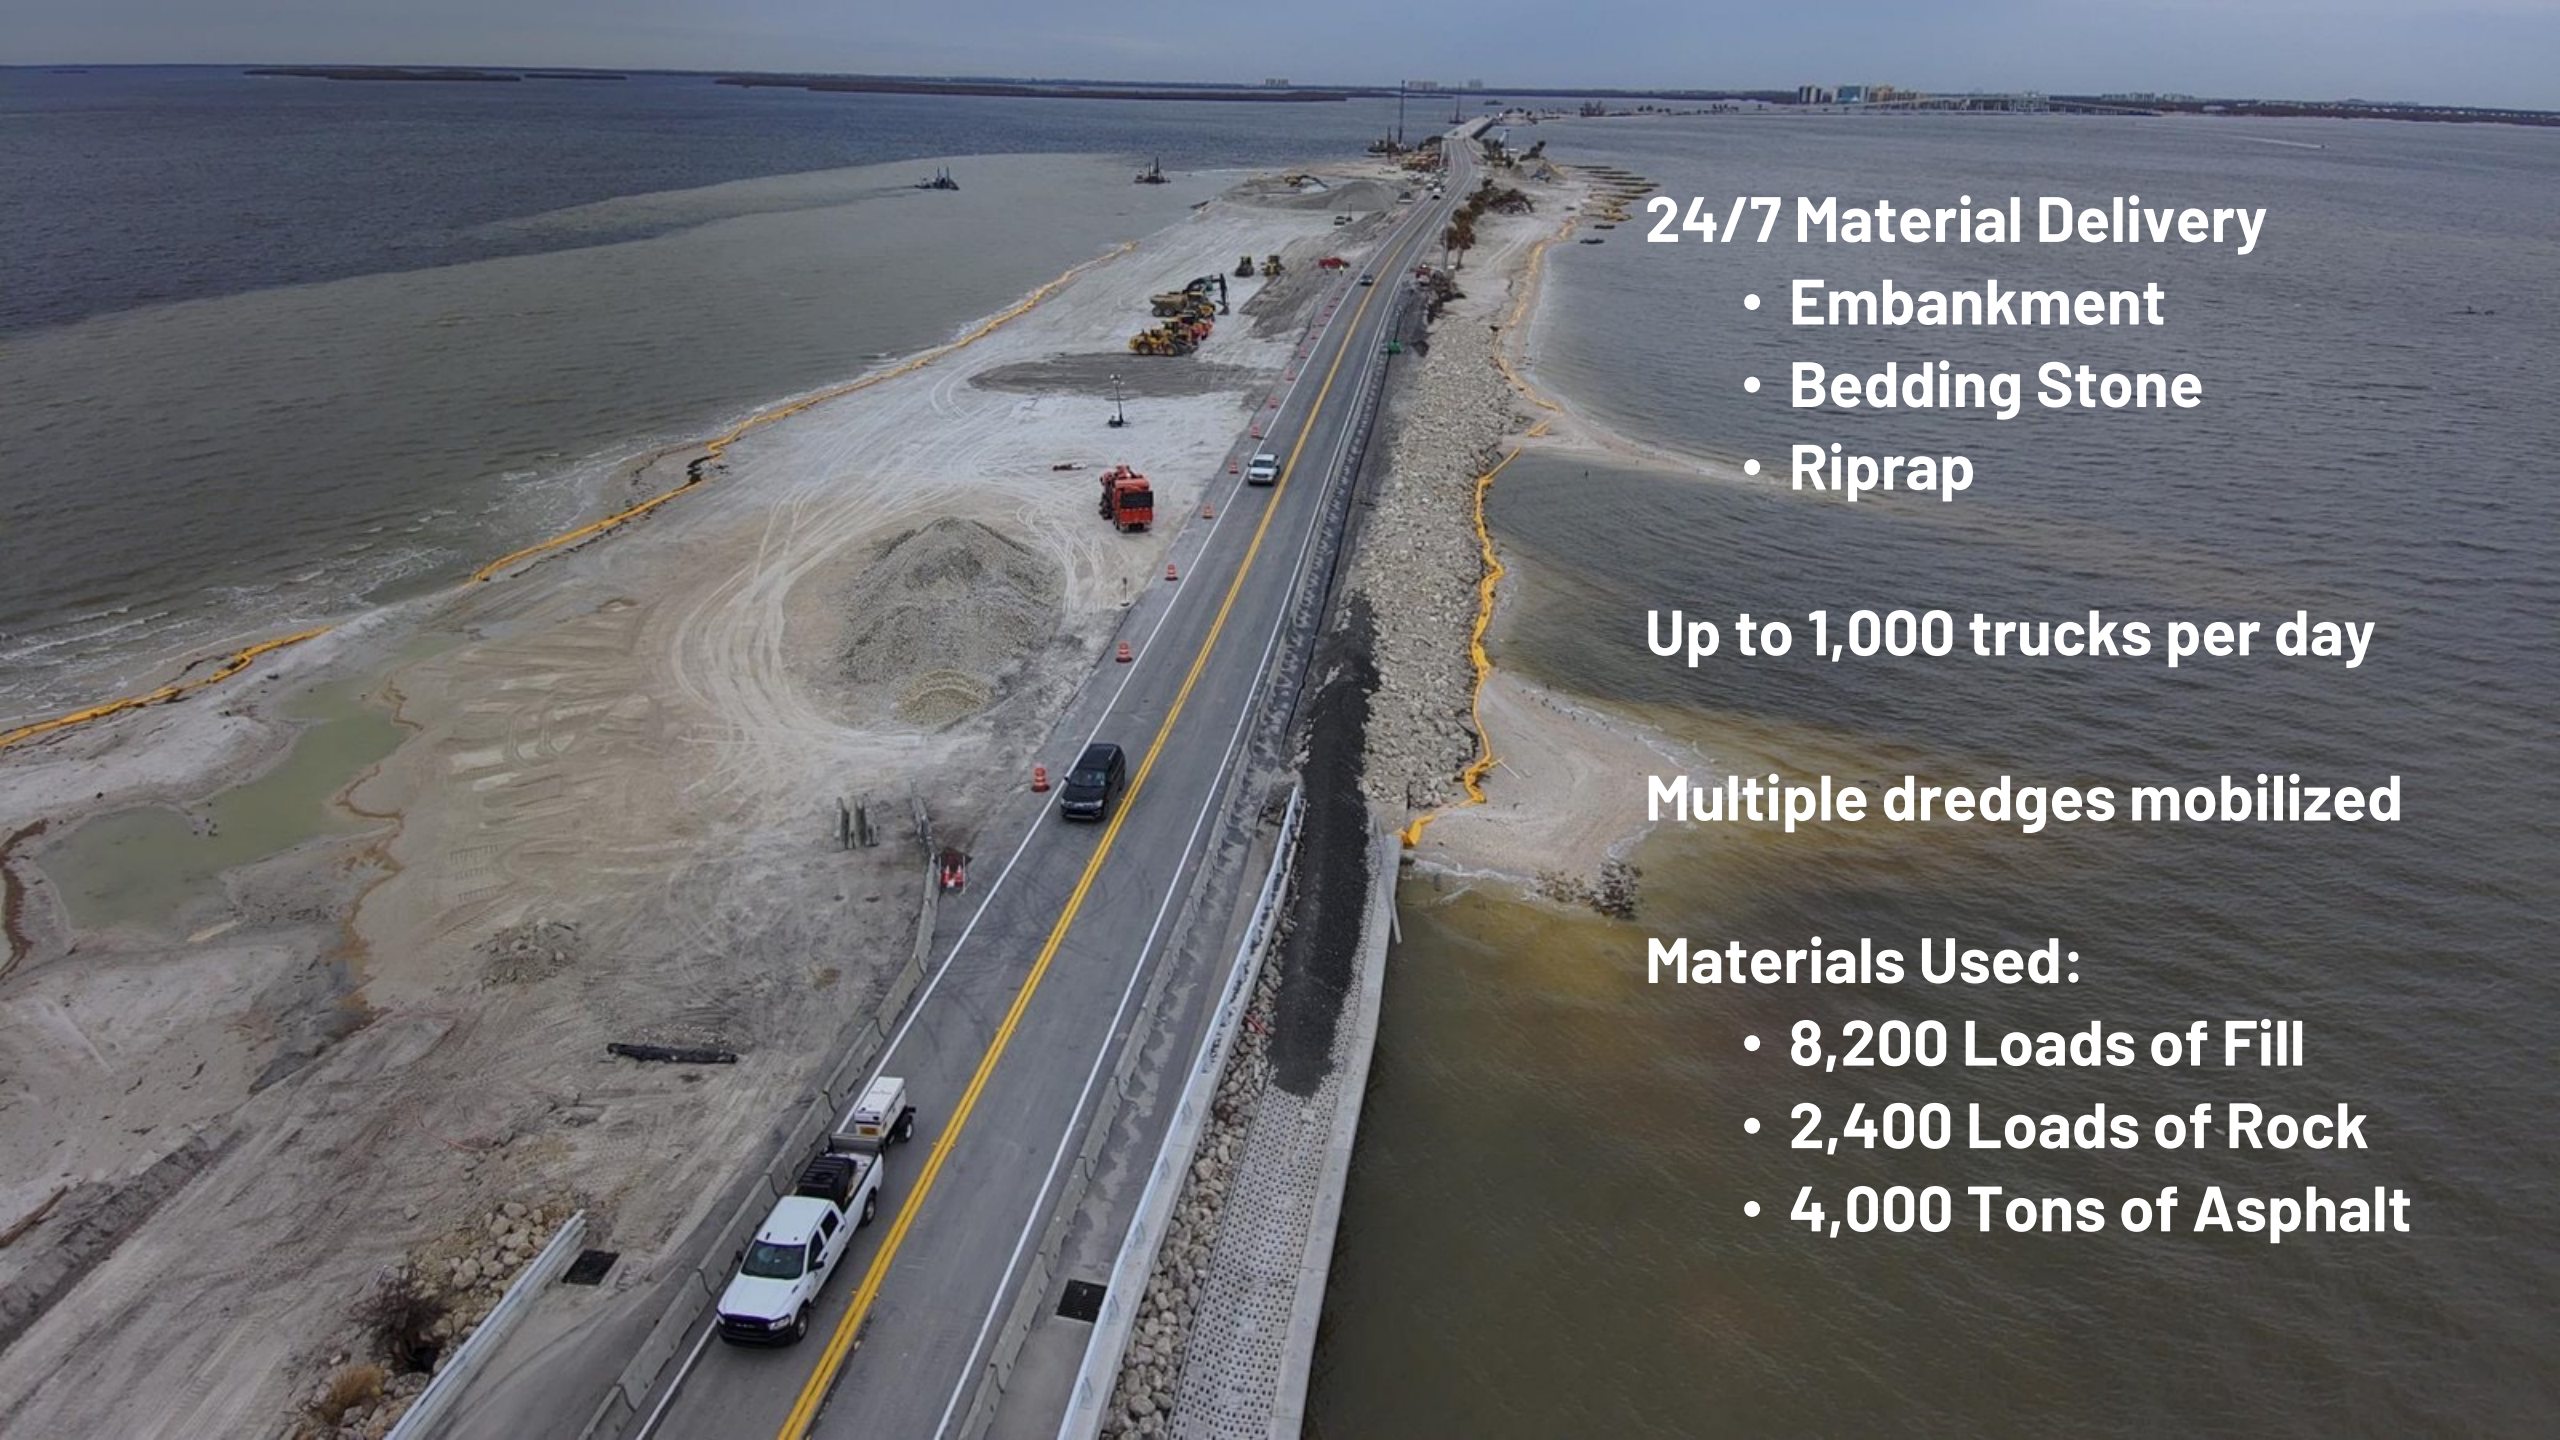
24/7 Operation

100+ Crew Per Day

36,000+ Workforce Hours

7 Days for Convoy Crossing

15 Days of Emergency Work

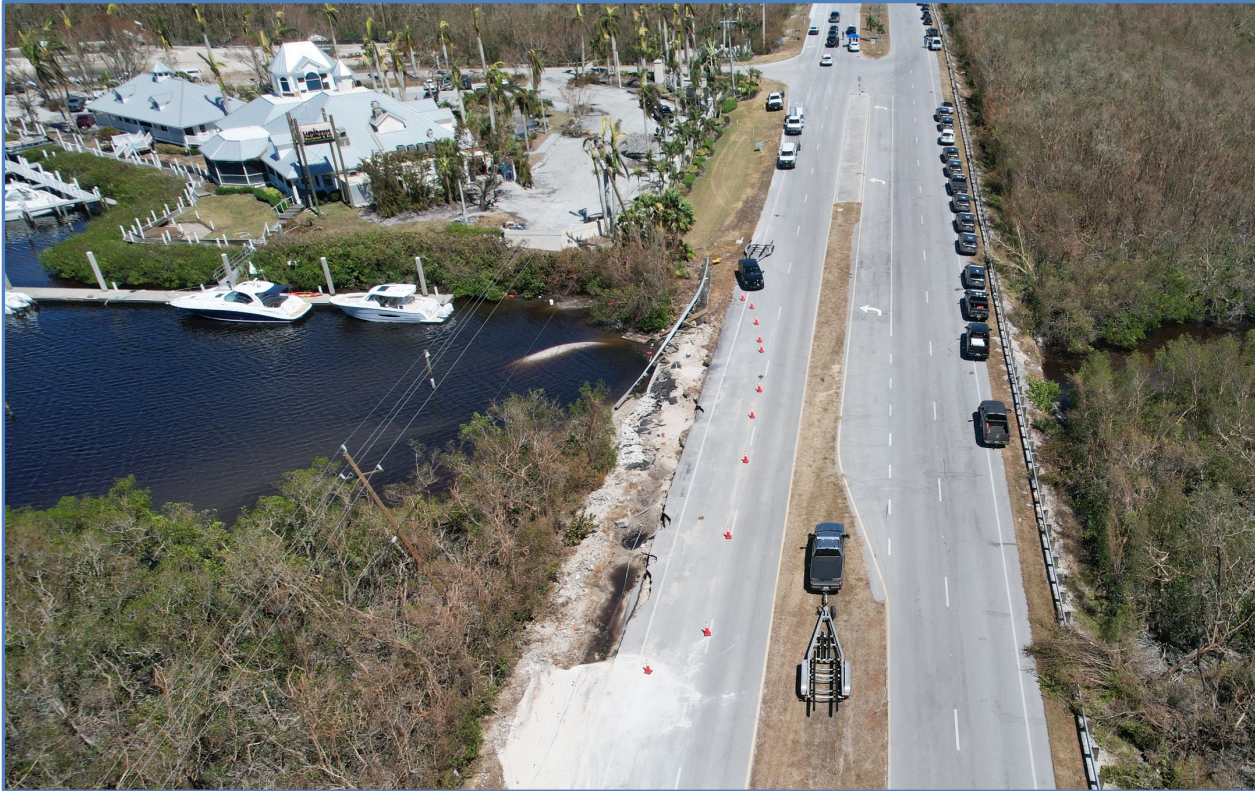
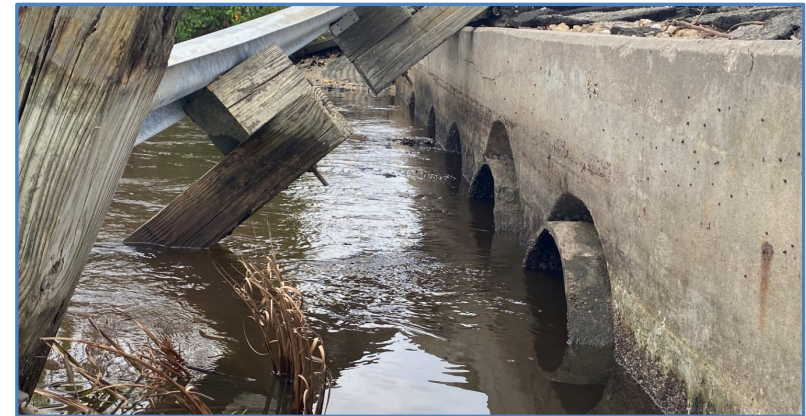
McGregor Blvd Port Comfort Pipe Crossing

Resilient Design Features:

Optimize number and size of pipes

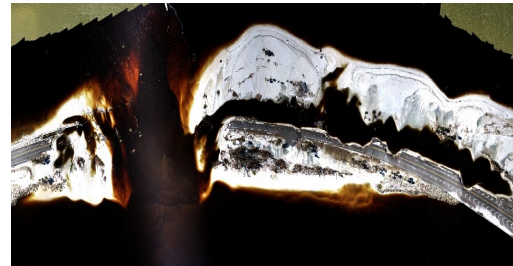
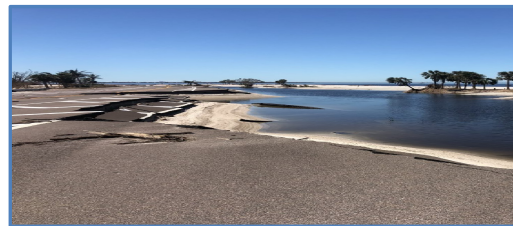
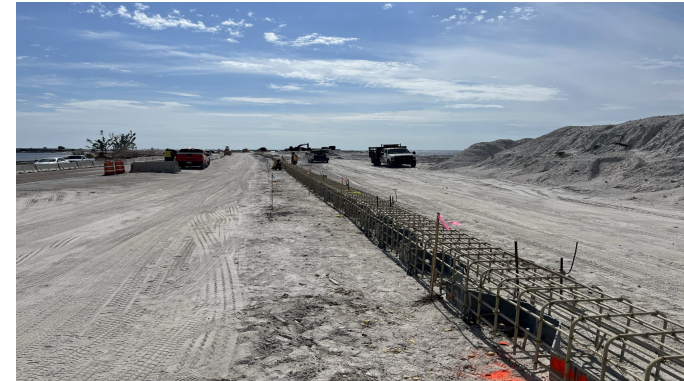
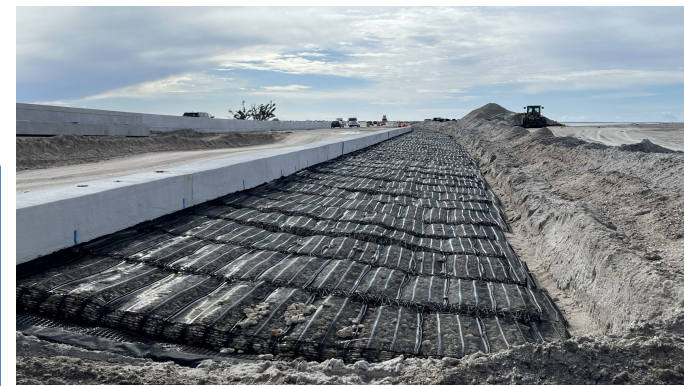
Sanibel Causeway Island Roadways

- Causeway elevations raised by 2 feet
- Buried wall protection
- Buried marine mattress and riprap

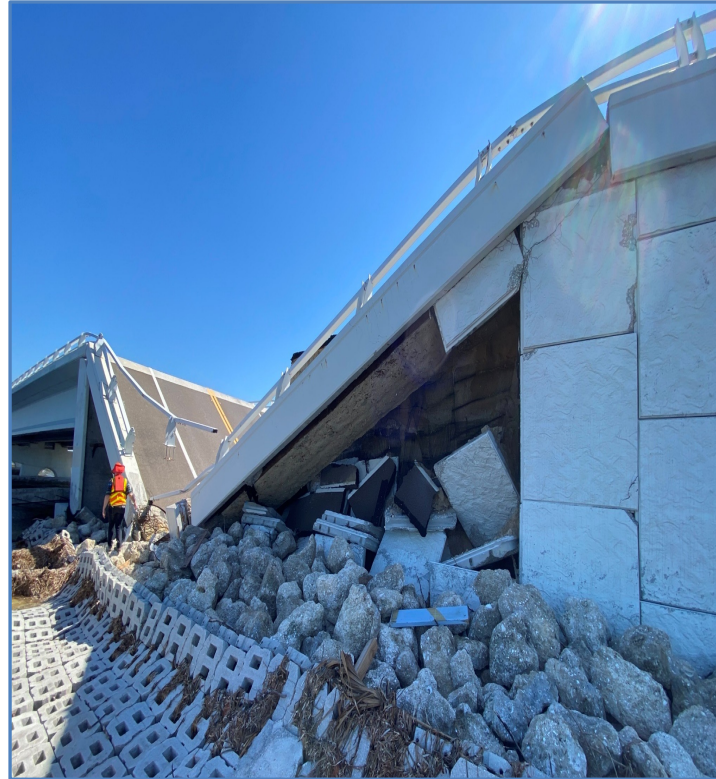
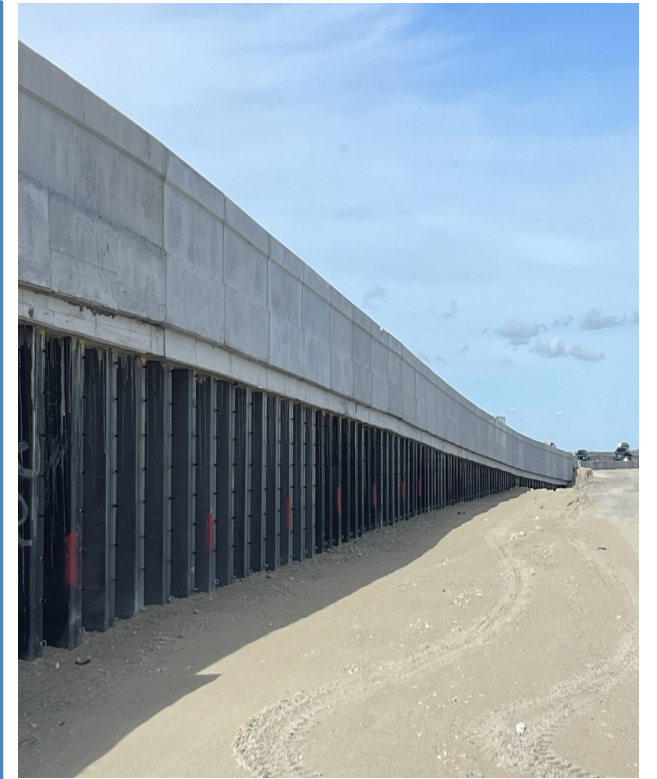
Resilient Design Features:

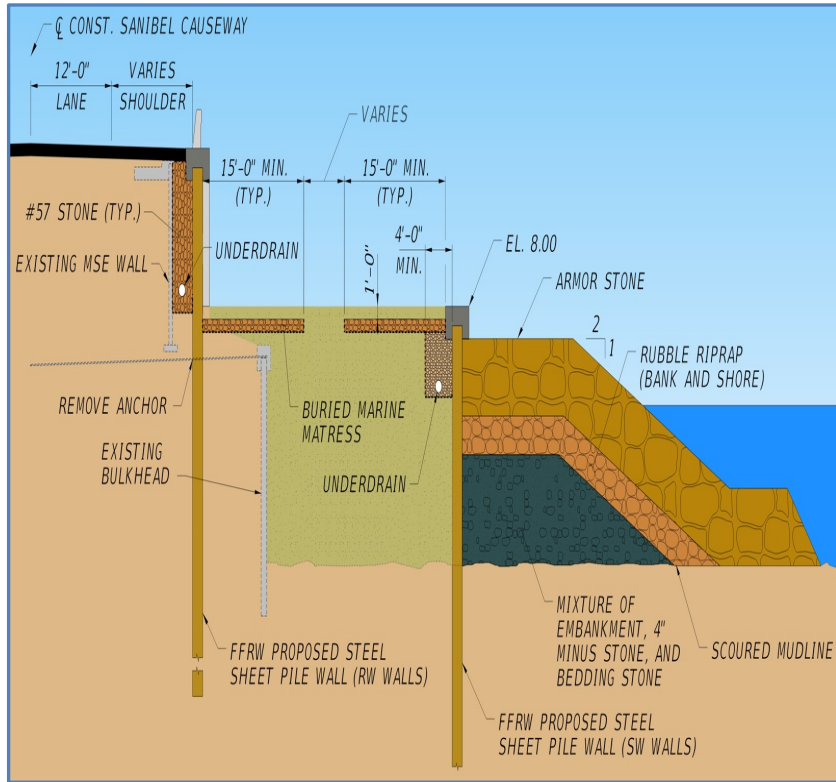
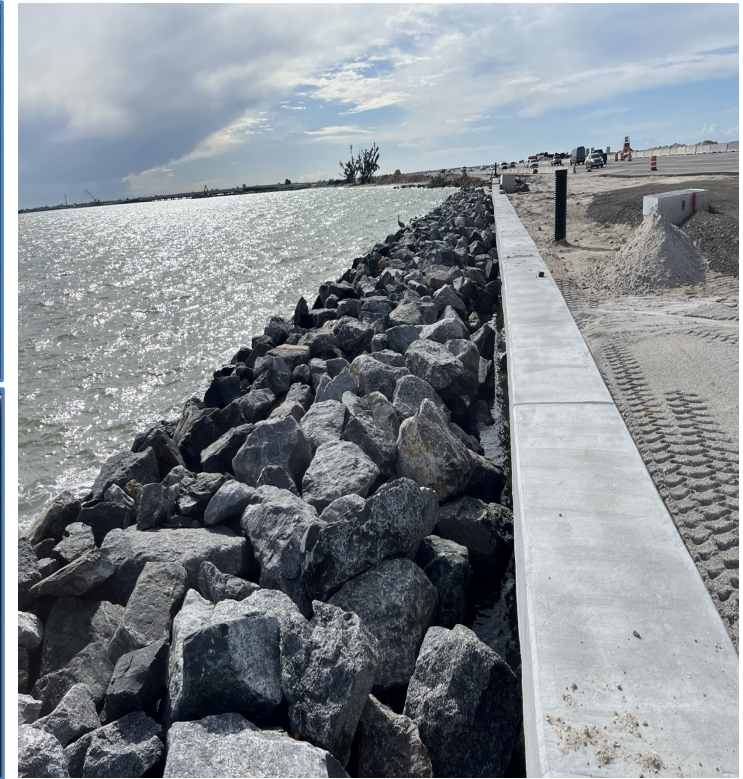
Sanibel Causeway Bridge Approaches

Resilient Design Features:

- Deep foundations in lieu of Mechanically Stabilized Earth (MSE) walls
- Under drain system
- Toe protection - Marine Mattress
